REPORT NO.
UCB/EERC-94/01
JANUARY 1994

EARTHQUAKE ENGINEERING RESEARCH CENTER

**PRELIMINARY REPORT ON THE
SEISMOLOGICAL AND ENGINEERING ASPECTS
OF THE JANUARY 17, 1994
NORTHRIDGE EARTHQUAKE**

UNIVERSITY OF CALIFORNIA AT BERKELEY

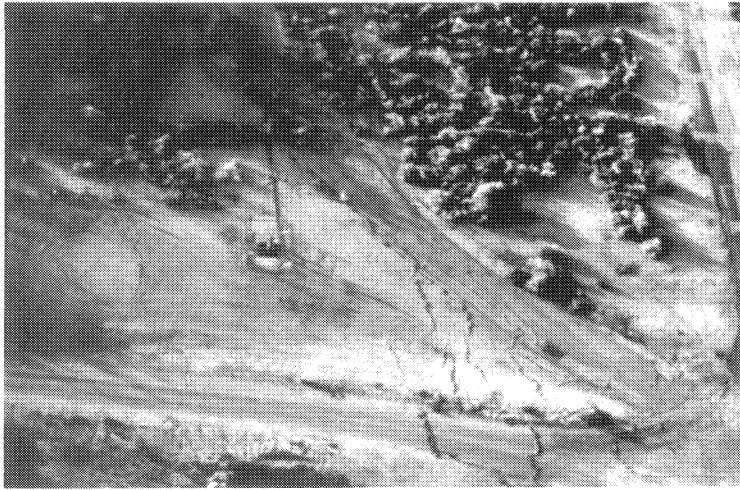
Figure 2.6: Ground ruptures within the Newhall-Potrero Oil Field along the northern edge of the Santa Susana Mountains.

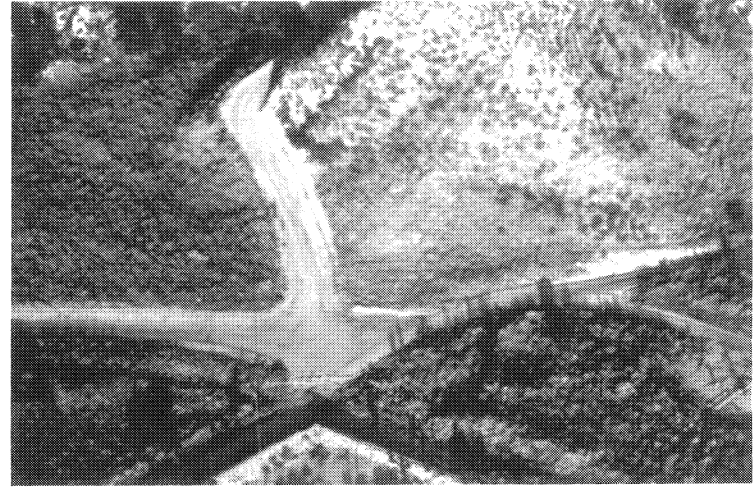
Figure 2.7: Ground ruptures within the Newhall-Potrero Oil Field along the northern edge of the Santa Susana Mountains.

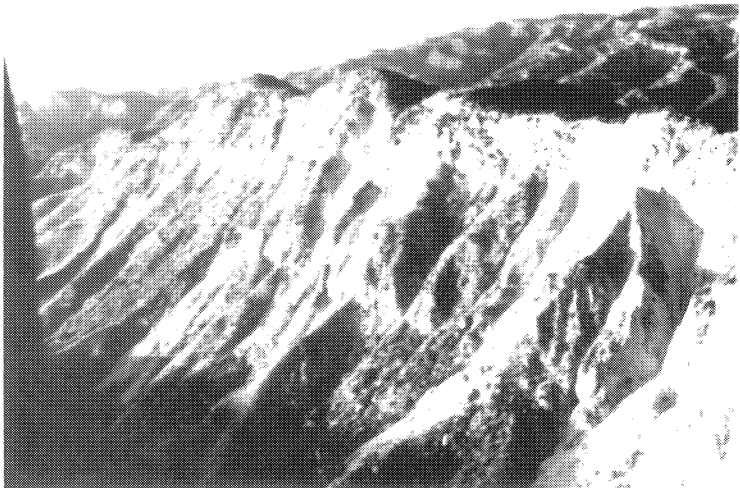
Figure 2.8: Displacements along steeply south-dipping bedding planes to the east of the Newhall-Potrero oilfield.

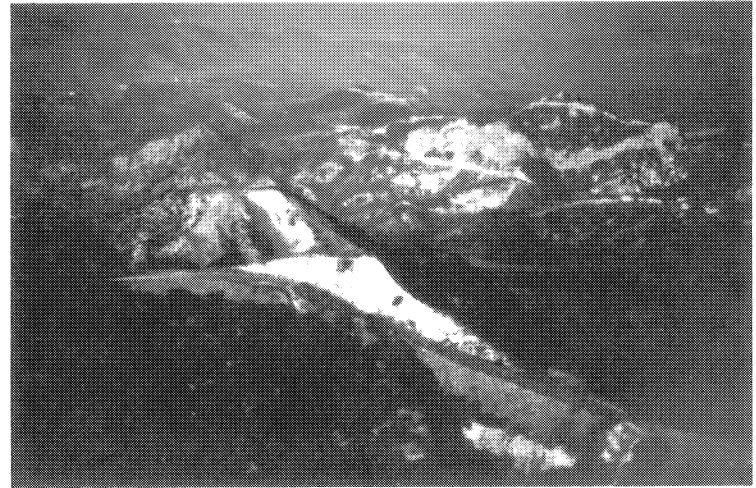
Figure 2.9: Typical rockfall, northwest of the Route 14/5 interchange, Santa Susana Mountains.

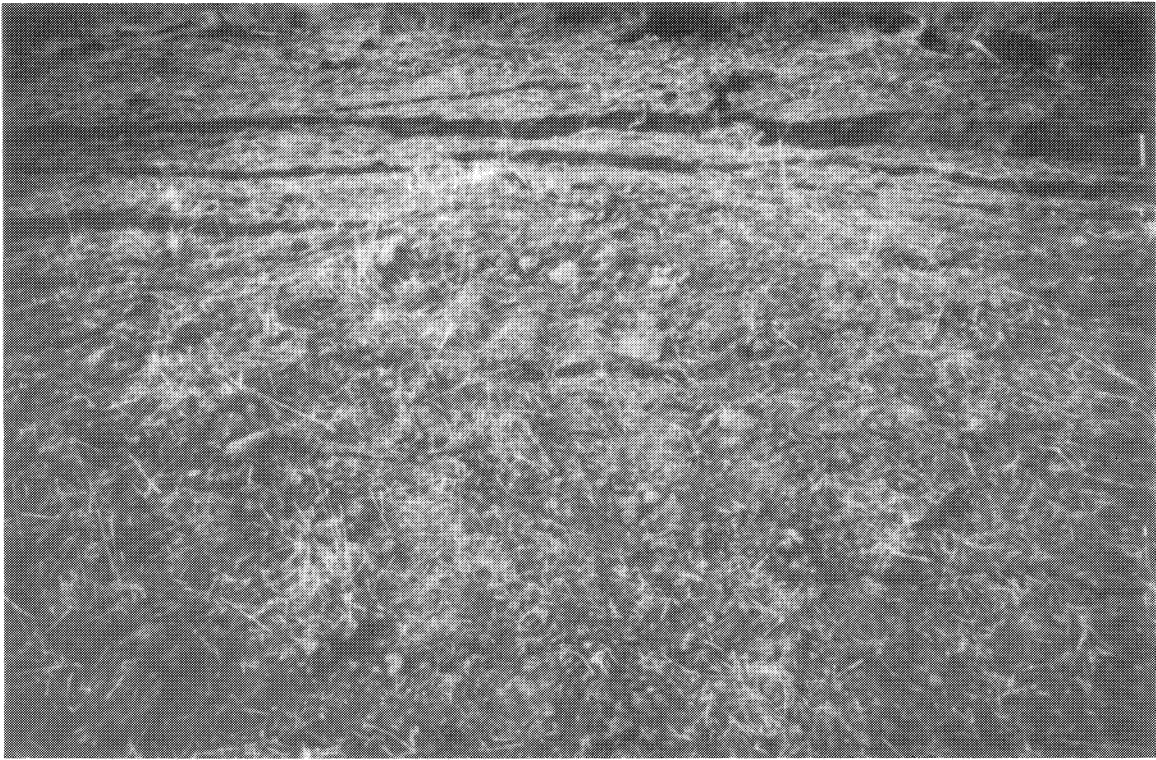
Linear ground breakage features, which are roughly parallel to the east-west trend of the mountain ridges, were observed along the northern and southern margins of the valleys within Potrero Canyon. The ground fractures tend to follow the topographic contours around the base of the hills, but they do cut linearly across alluvial deposits at numerous locations. On the northern margins of the valleys, the fractures are primarily extensional, with minor right-lateral offsets. Multiple ground fractures within zones 5 to 30 feet wide accommodate as much as 2 feet of vertical movement (see Figure 4.2). The width of the fractures vary from less than ¼-inch to as much as 4 inches. Extensional features are also observed along the southern, eastern and western margins of the valleys. Minor left-lateral offsets occur along the southern margins of the valleys. Compressional features, however, are found along the southern margins of the valleys at a number of locations. These features include shallow thrusting along distinct shear surfaces that dip to the south at approximately 30 to 40 degrees with up to 6 inches of dip-slip displacement. Headscarps in the hills above these thrust features, which might have indicated that they represented toes of landslides, could not be found. Evidence of localized compression was also noted at the entrance to valleys (e.g., see Figure 4.3), but a majority of the significant ground fracturing in this area was extensional.

Fig. 4.2: Extension feature at soil to bedrock contact in Potrero Canyon. Note 1-foot long ruler at right side of photograph.

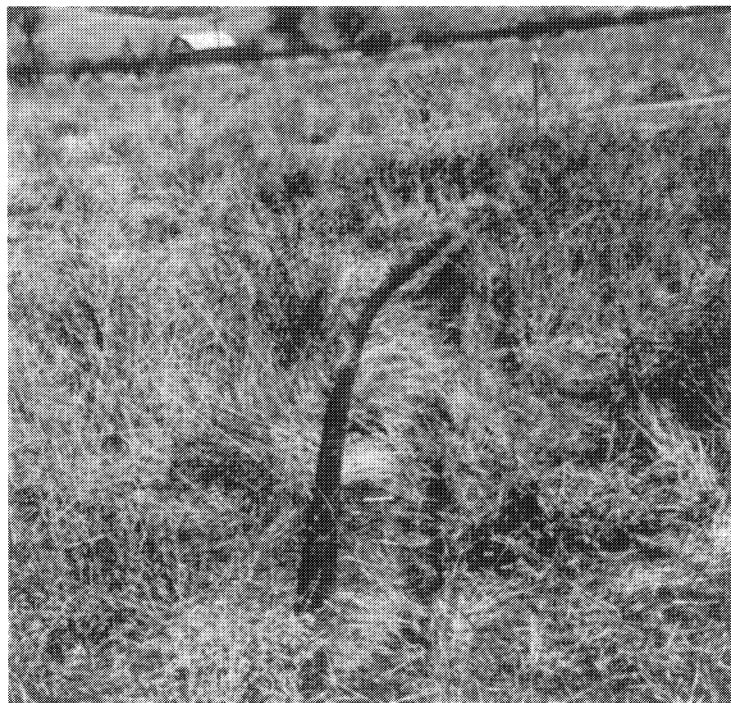
Fig. 4.3: Evidence of localized compression in Potrero Canyon. Note that originally straight pipe was pushed up and laterally; shortening across its length was 5 inches.

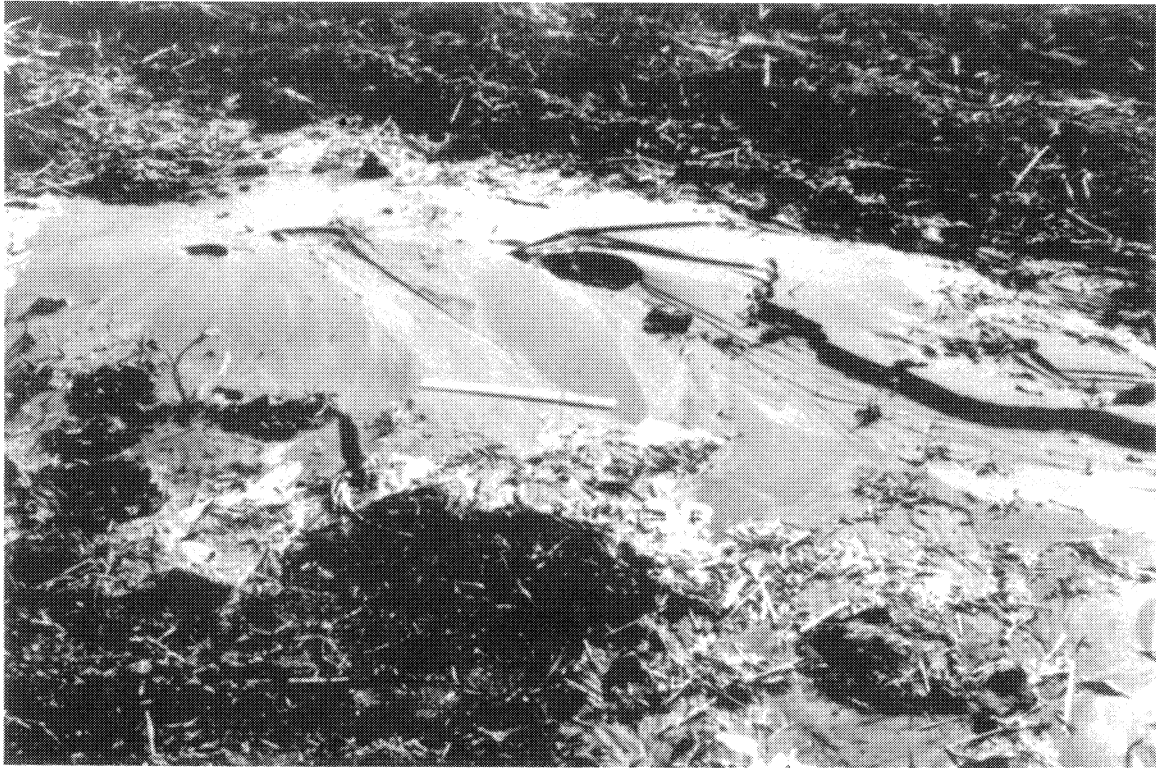
Fig. 4.4: Liquefaction of sand deposit with appreciable fines content in Potrero Canyon

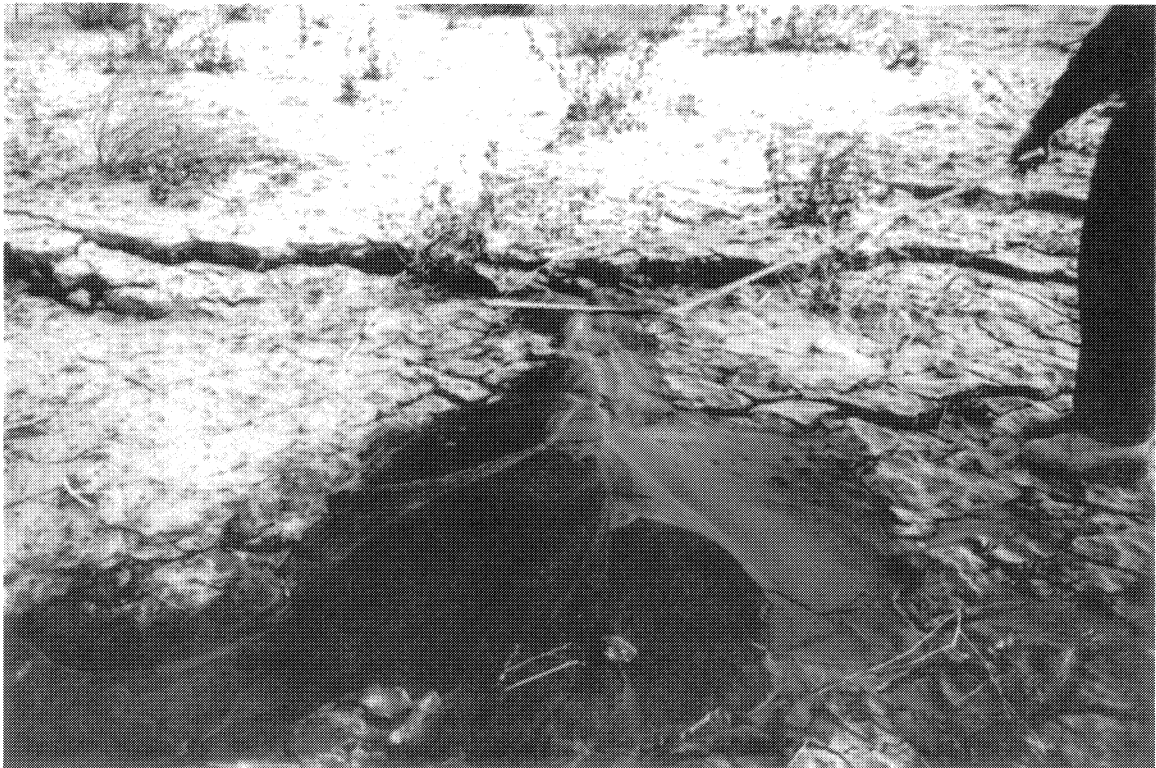
Farther east, liquefaction was observed in the dry lakebed behind Hansen Dam, a U.S. Army Corps of Engineers flood control dam that at the time of the field inspection was not impounding water. Sand boils up to 3 feet in diameter, and sand fissures up to 50 feet long and 6 inches wide, were observed upstream of the reservoir flood zone across an approximately 300 by 1000-foot area near several ponds. Sand boils from this area are shown on Figures 4.5 and 4.6. Surprisingly large flows were observed to have been exuded from several boils and fissures which resulted in localized erosion. Lateral spreading of up to 3 feet and settlements of about one foot were also noted in some areas.

Fig. 4.5: Lateral spreading fissure and sand boil at dry lakebed behind Hansen Dam

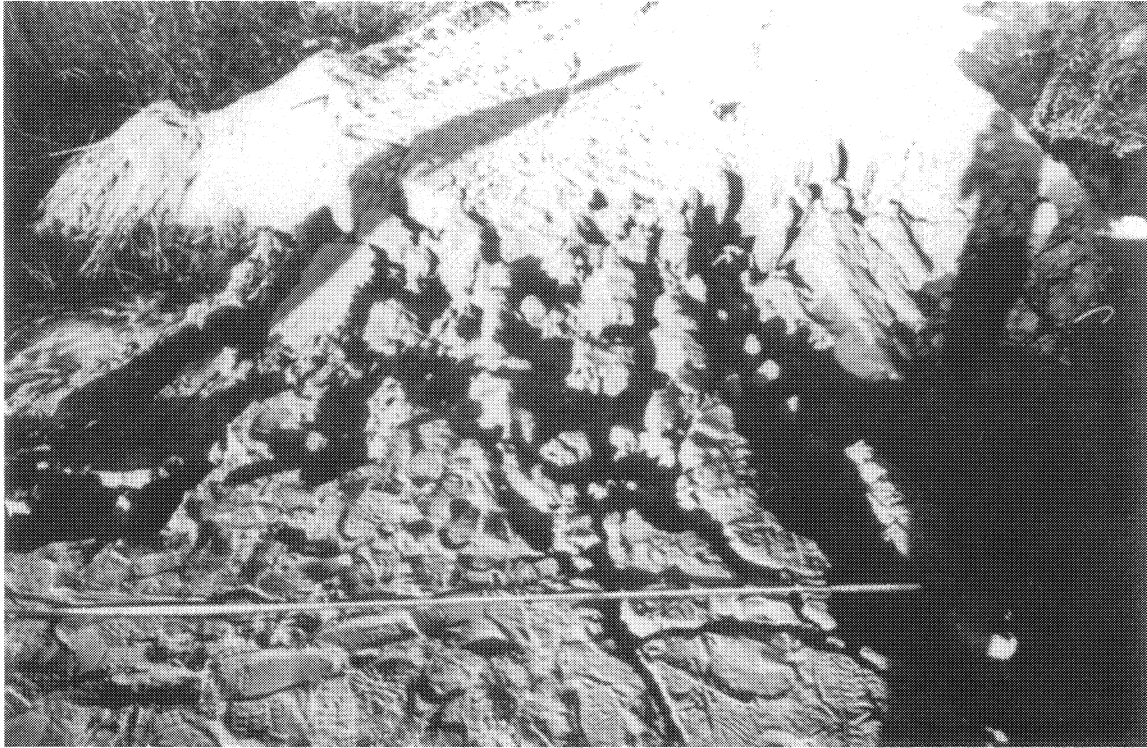
Fig. 4.6: Roadway damaged by liquefaction and lateral spreading failure at dry lakebed behind Hansen Dam

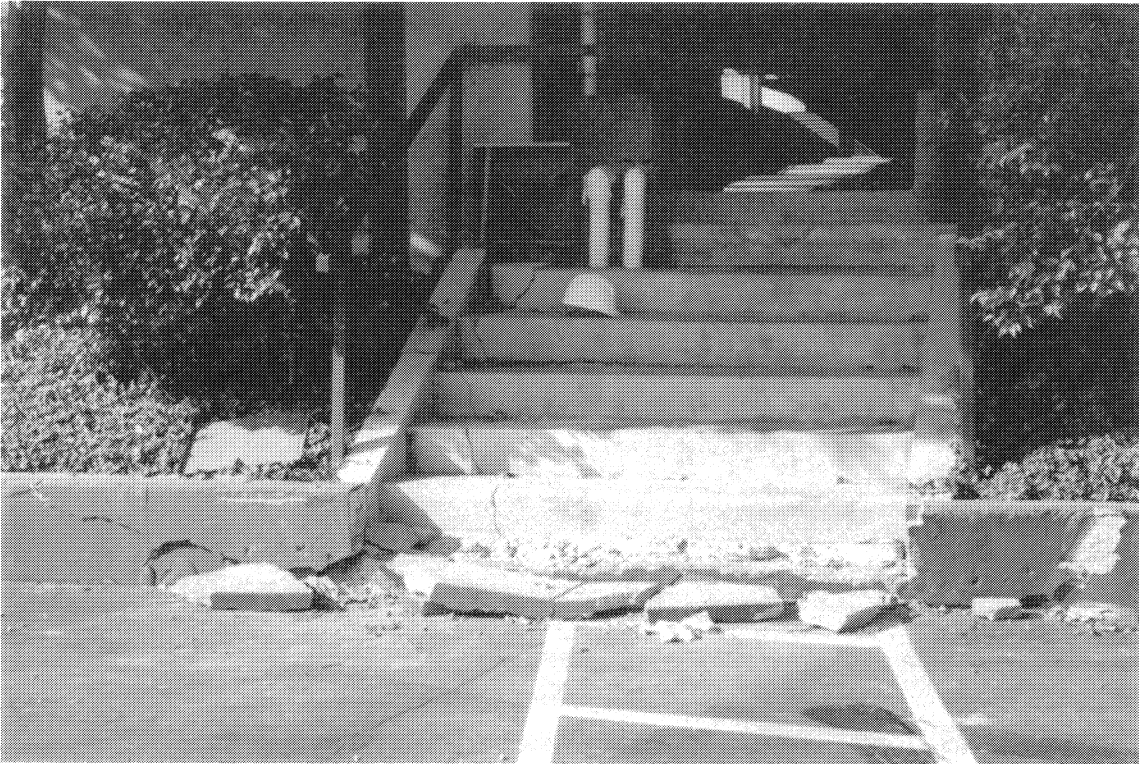
The city of Granada Hills, located north of Northridge, and northern and central Northridge experienced significant ground movement as evidenced by numerous cracks in streets and broken and buckled curbs (Figures 4.7 and 4.8). Significant ground fracturing was found west of Woodley Ave., south of Midwood Dr., east of Shoshone Avenue, and north of Highway 118. Figure 4.9 is an example of a compressional feature due to lateral spreading in this general area, whereas Figure 4.10 is an example of lateral spreading clearly

Fig. 4.7: Damage from lateral spreading, Northridge Hospital

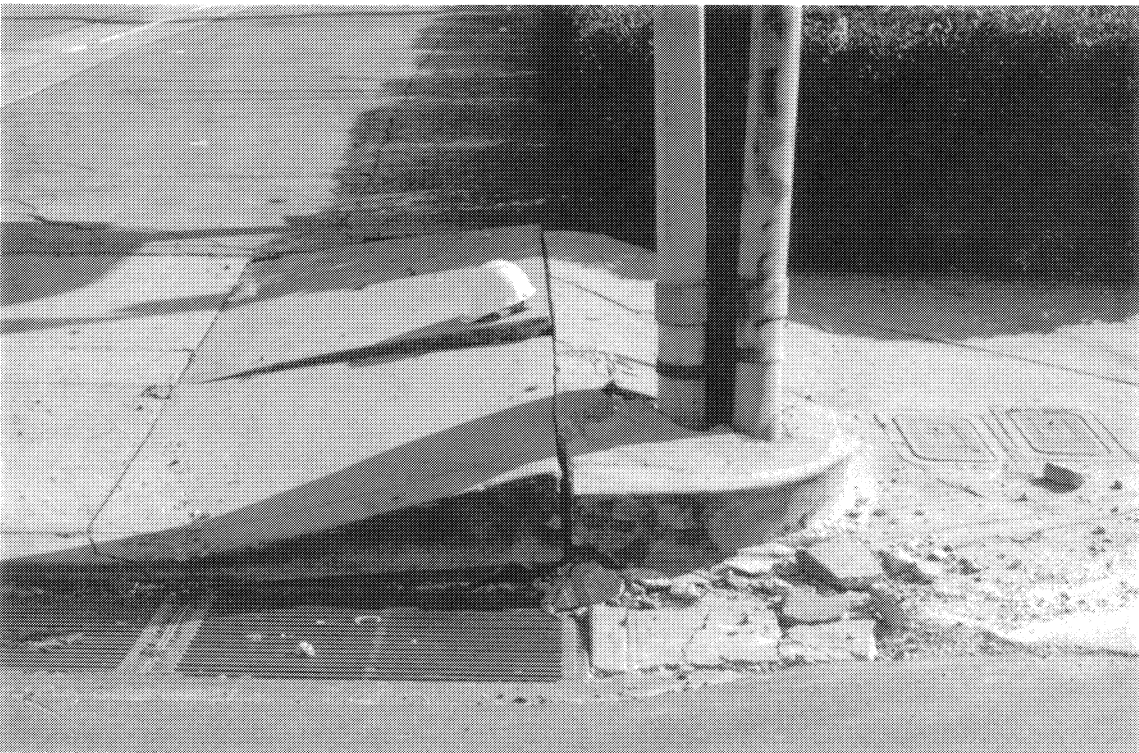
Fig. 4.8: Buckling of curb from lateral spreading, Northridge Hospital

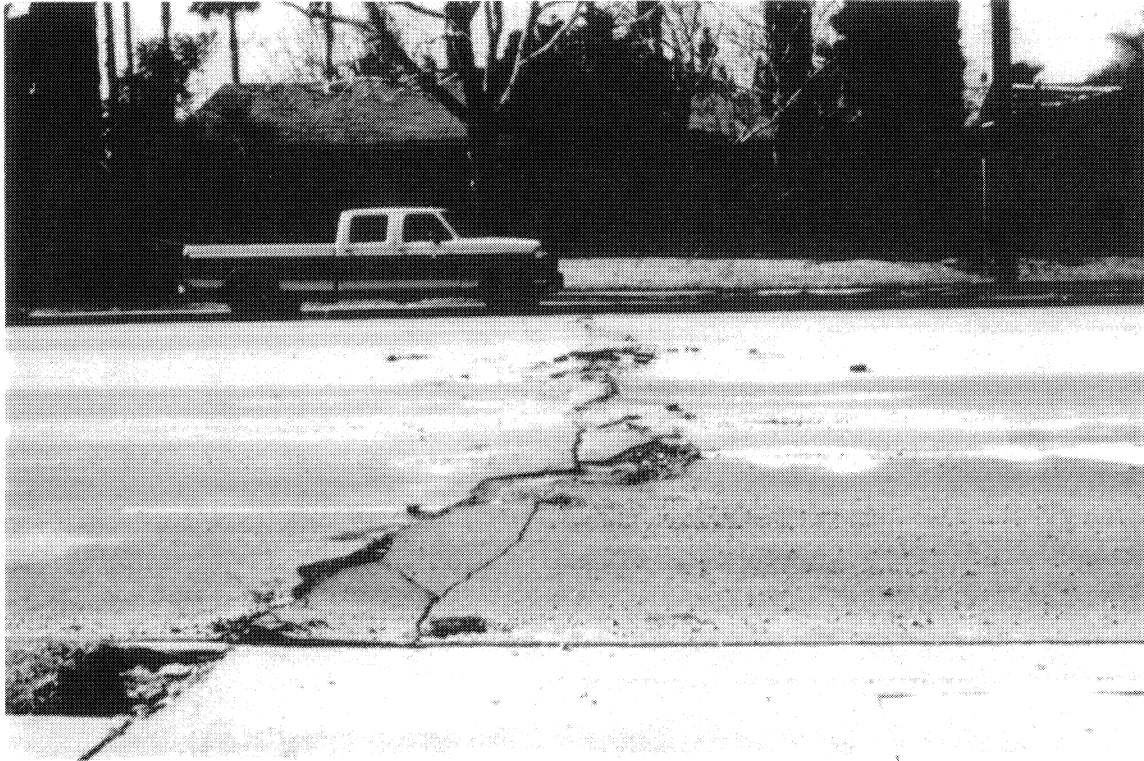
Fig. 4.9: Localized compression feature and pavement damage in Northridge near Highway 118

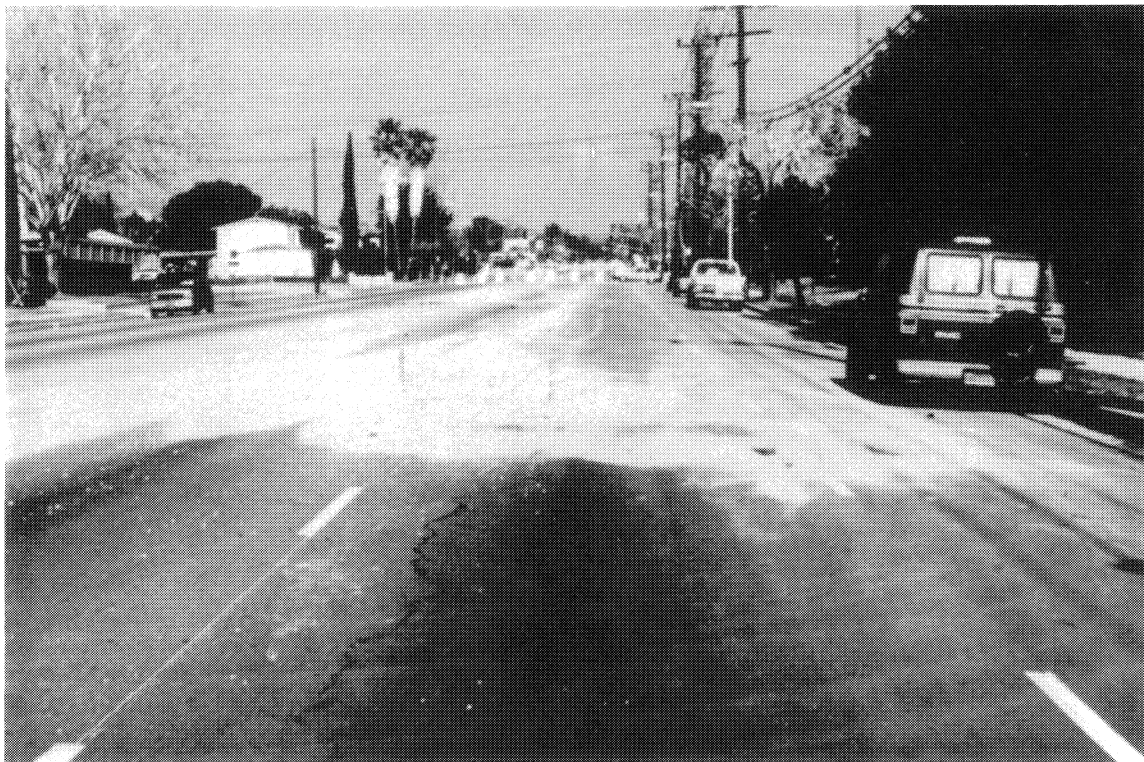
related to soil liquefaction. The cracks are typically up to 2 inches wide in the asphalt concrete pavement, although in one case a 6 inch separation between a house foundation and the adjacent ground was noted. The ground cracking generally trends east to west and continues for more than one mile. This area was also the site of numerous water and gas pipe breaks. The water pipes (68 and 48 inch diameter) and the gas pipe (12 inch diameter) on Balboa Boulevard just north of Rinaldi Street, were separated by 8 to 12 inches according to the repair crew at the site. At one location nearby, a maintenance crew reported that a 1-inch diameter pipe separated six inches and was displaced six inches laterally.

Fig. 4.10: Evidence of liquefaction and lateral spreading, northeast Northridge

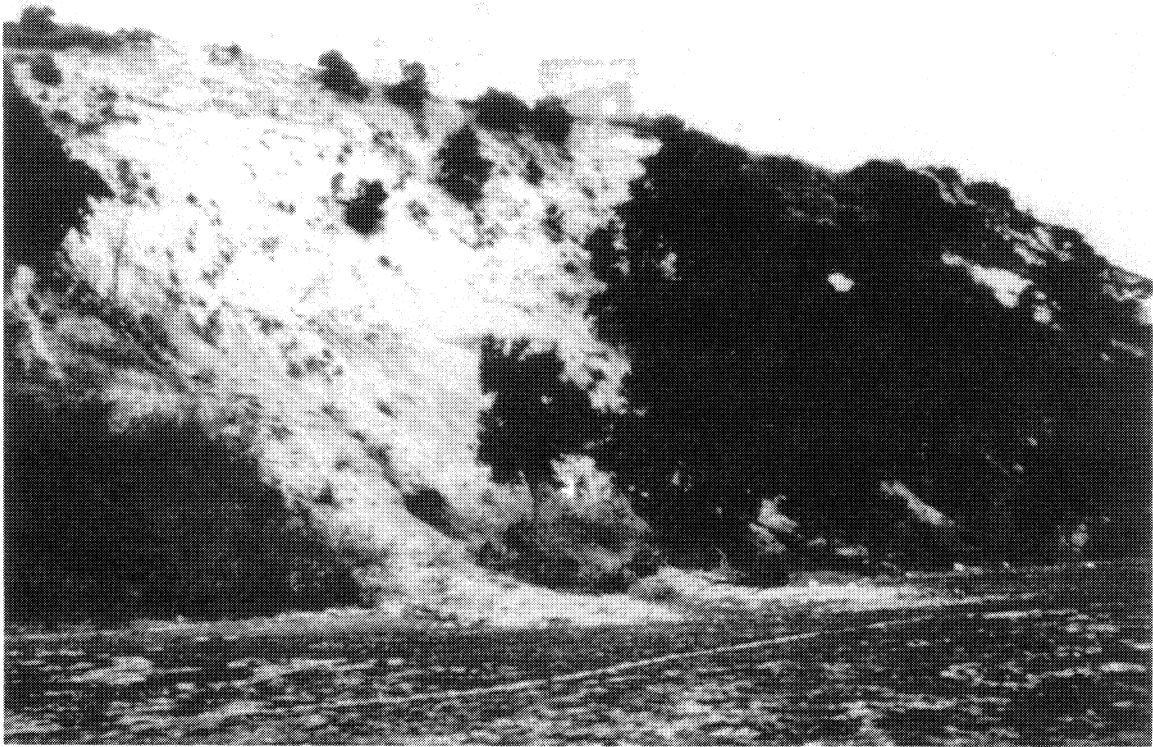
Fig. 4.11: Bluff failure and ravelling on Highway 126 near Piru

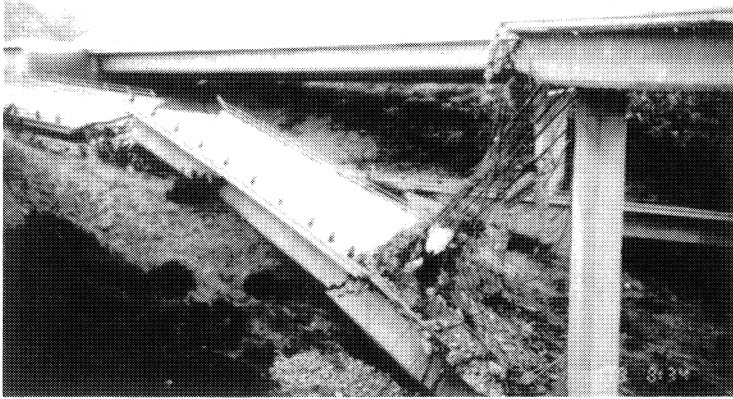
Fig. 5.2: Overview of Interstate 5/Route 14, North Connector Failure

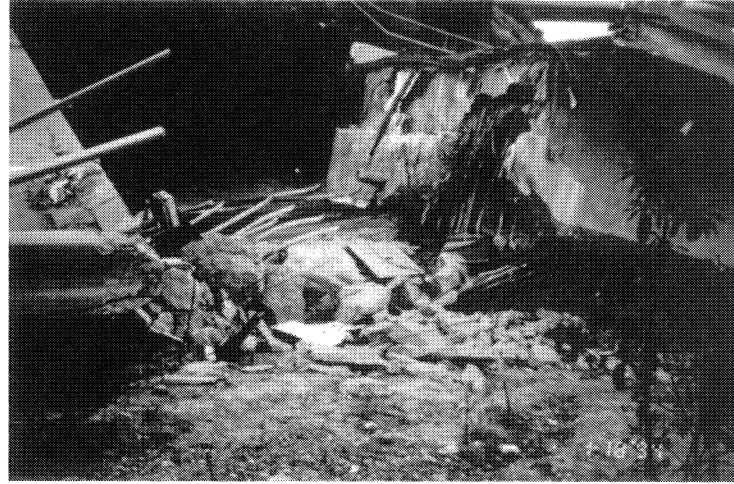
Fig. 5.3: Bent 2 of Interstate 5/Route 14, North Connector

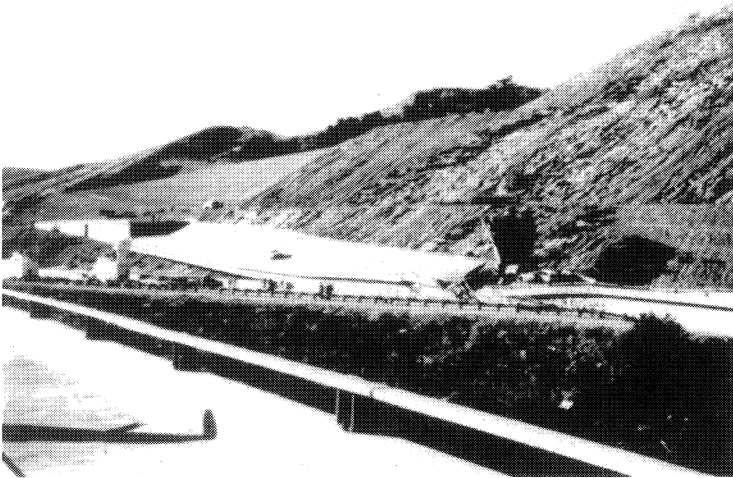
Fig. 5.4: Overview of Interstate 5/Route 14, South Overhead Failure

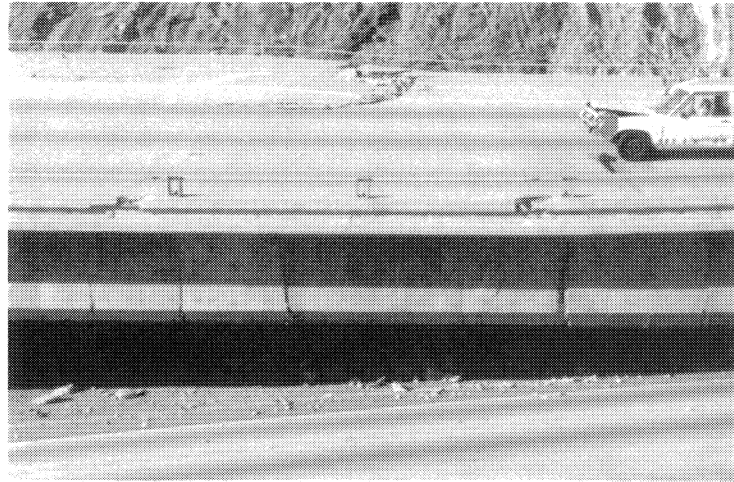
Fig. 5.5: Bent 2 of Interstate 5/Route 14, South Overhead

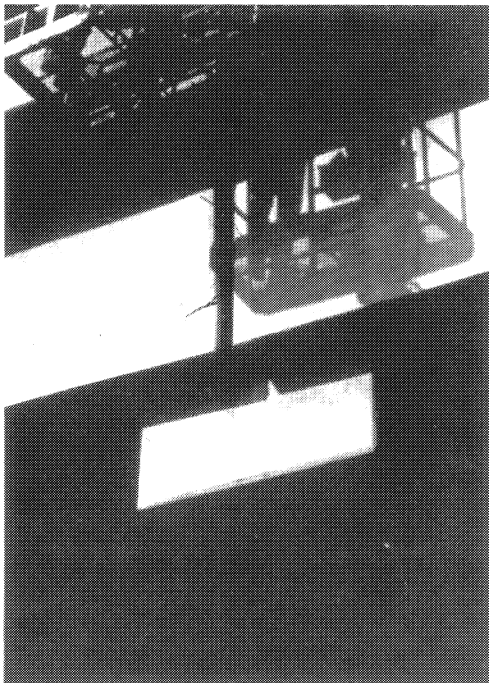
Fig. 5.8: Seat Failure at Connector from West Interstate 10 to South Interstate 405

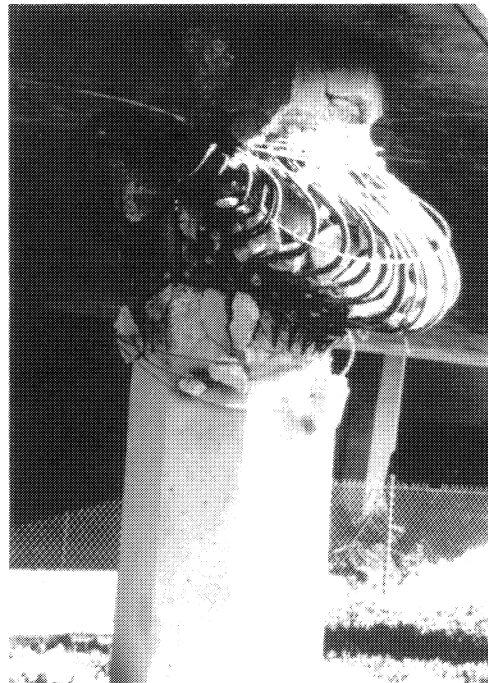
Fig. 5.9: Column Failure at Bent 2, Bull Creek Canyon Channel Bridge

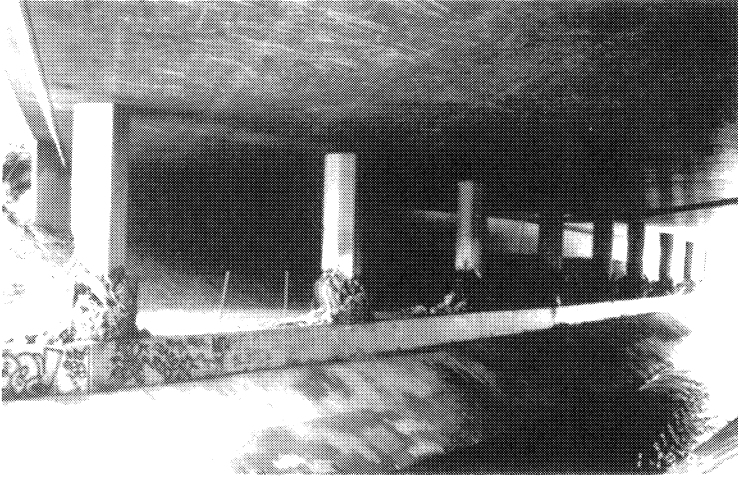
Fig. 5.10: Column Failure at Bent 3, Bull Creek Canyon Channel Bridge

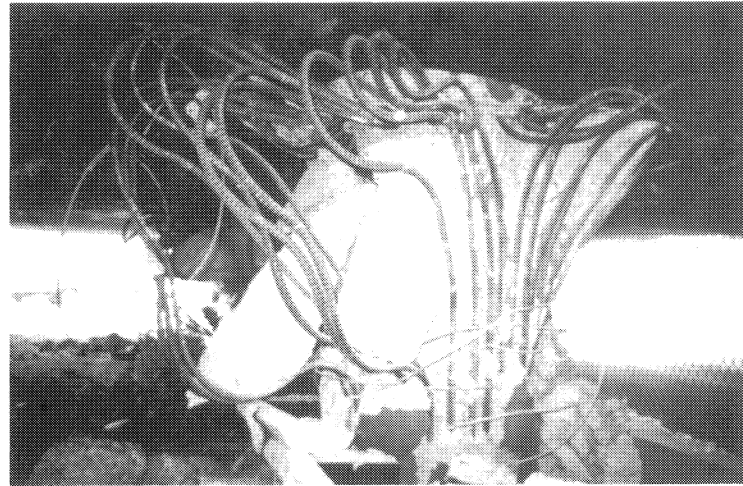
Fig. 5.15: Column Failure at Fairfax Overcrossing

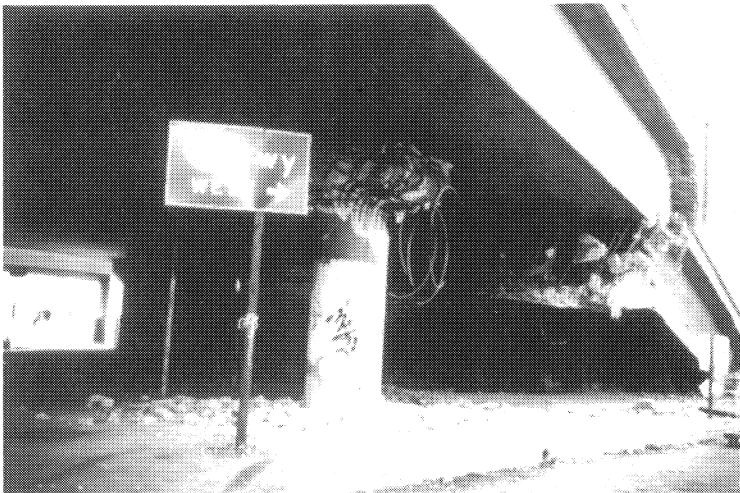
Fig. 5.16: Overview of La Cienega–Venice Undercrossing Collapse

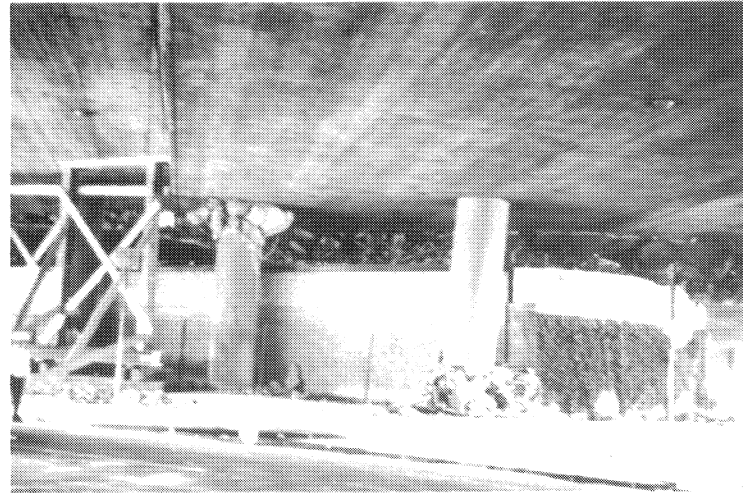
Fig. 5.17: Column Failure at Bent 7, La Cienega–Venice Undercrossing

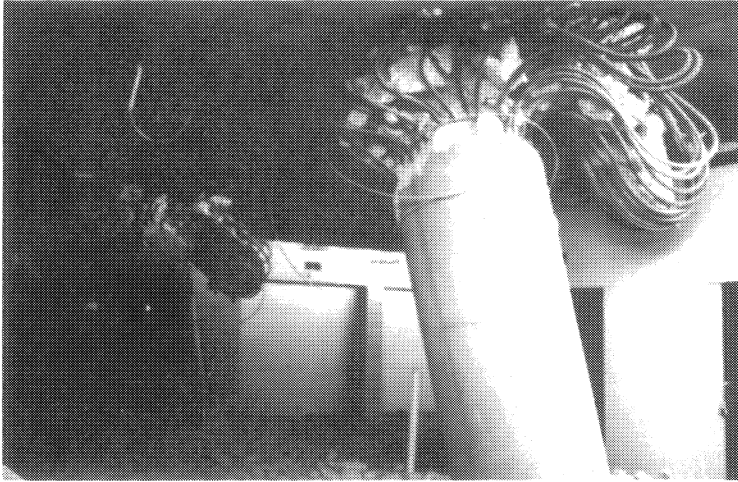
Fig. 5.18: Column Failure at Bent 6, La Cienega–Venice Undercrossing

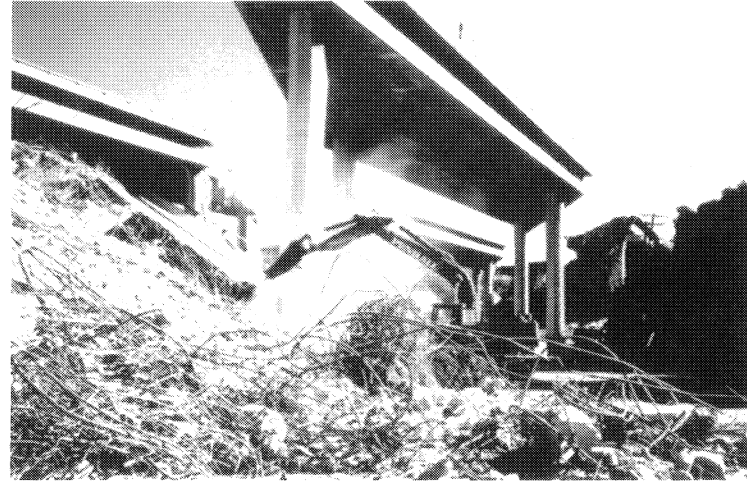
Fig. 5.19: Collapsed Spans at Gavin Canyon Undercrossing

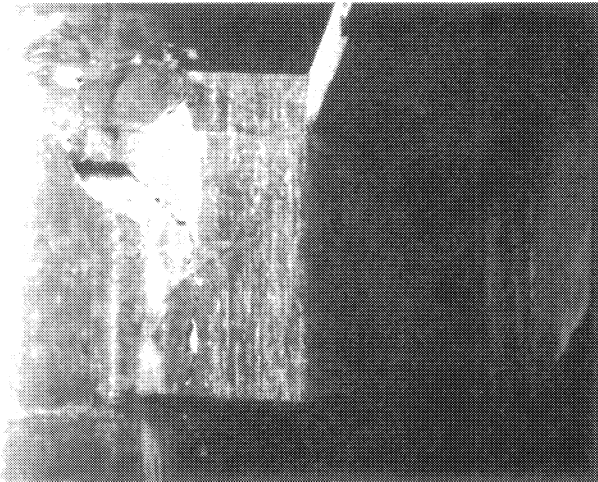
Fig. 5.20: Joint Failure at Jefferson Blvd. Undercrossing

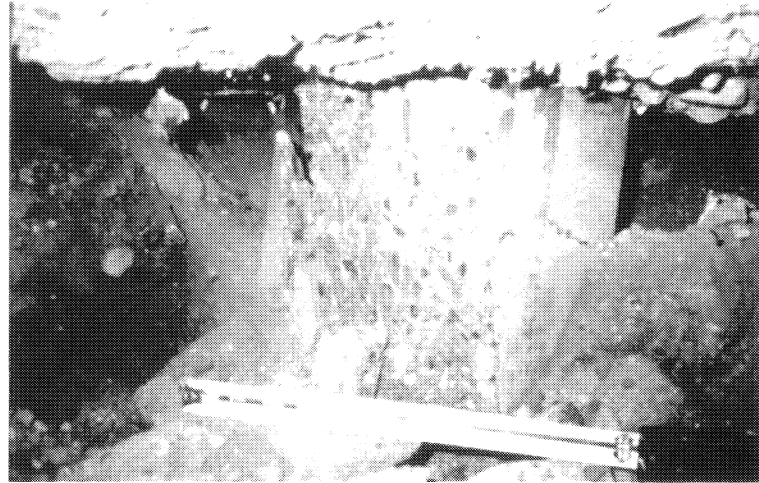
Fig. 5.23: Pile Damage at Los Virgenes Overcrossing

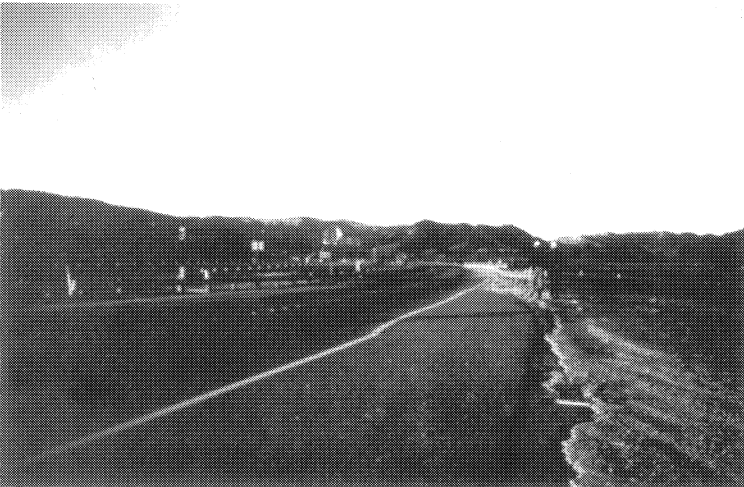
Fig. 5.24: Ground Cracks at East Approach of Interstate 5/Route 126 Separation

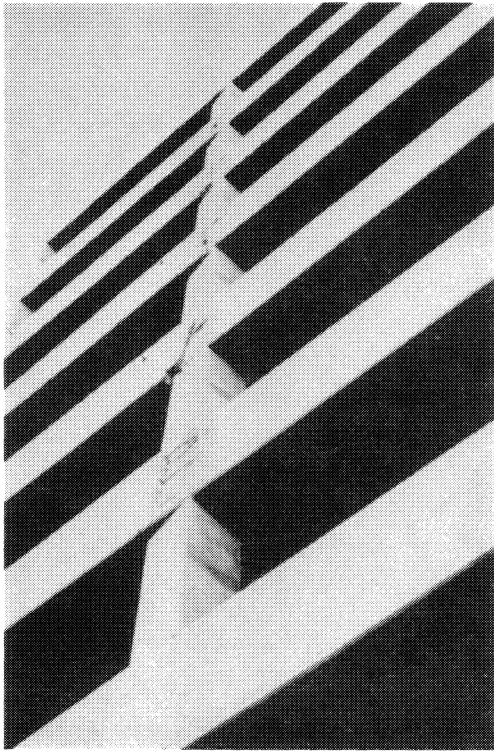
Fig. 6.1 Cast-In-Place Parking Garage With Joint Shear Failure

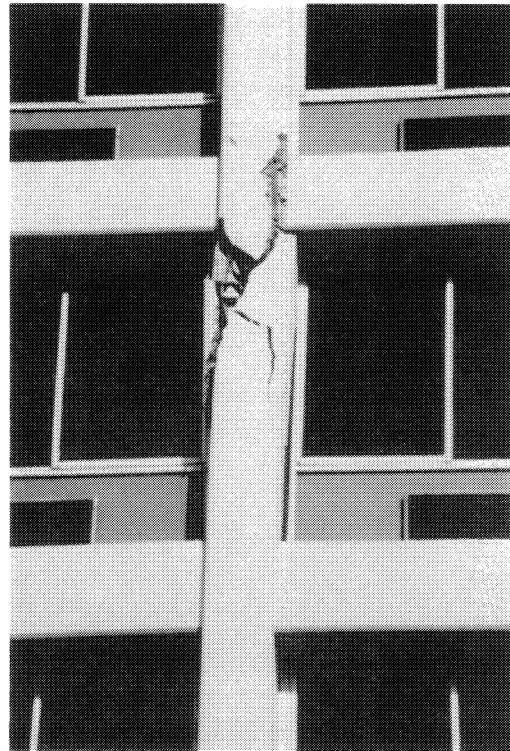
Fig. 6.2 Shear-Bond Failure in Columns of 7-Story Moment Resisting Frame

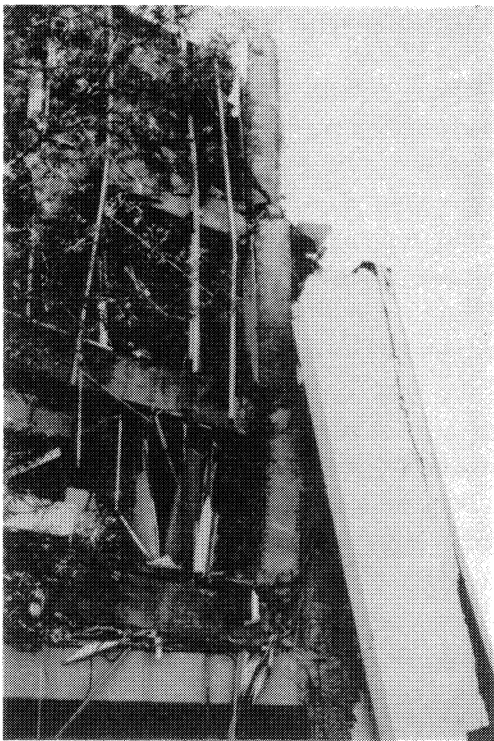
Fig. 6.3 Nonductile Reinforce Concrete (RC) Frame with Soft Story Mechanism

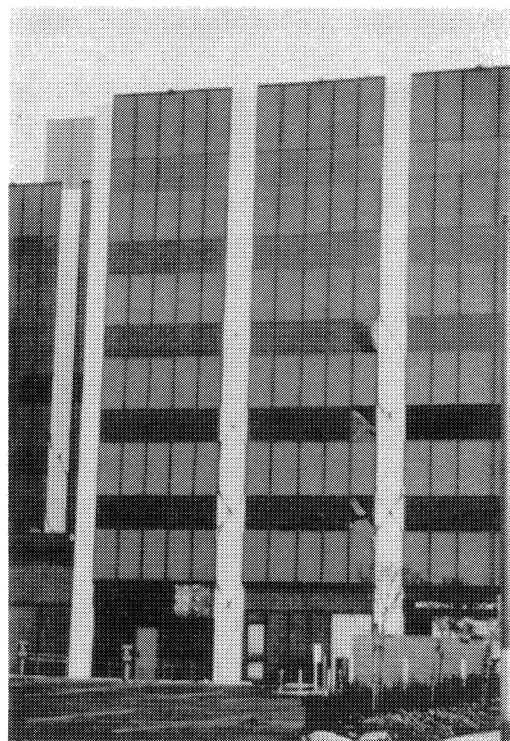
Fig. 6.4 Short Column Behavior in 6-story RC Moment Resisting Frame

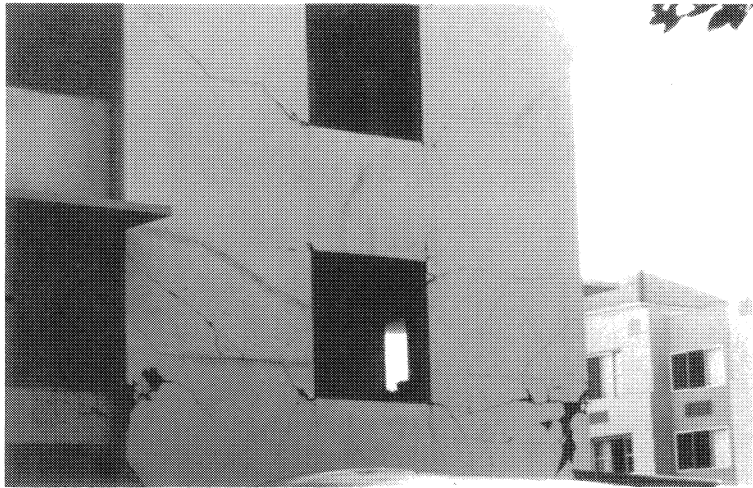
Fig. 6.5 Damage to Shear Wall of Dual Frame-Wall System

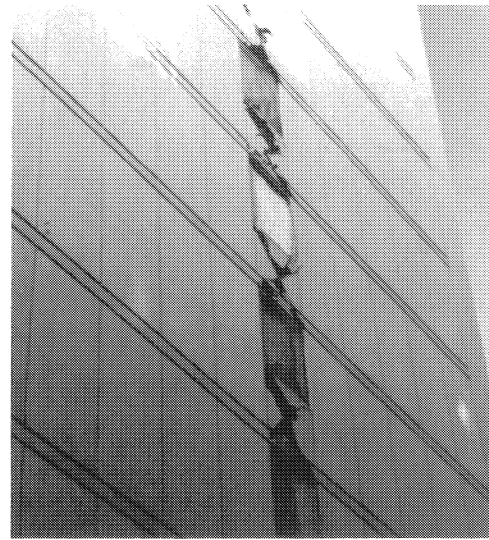
Fig. 6.6 Shear Failure of Coupling Beams in 15-story Coupled Shear Wall

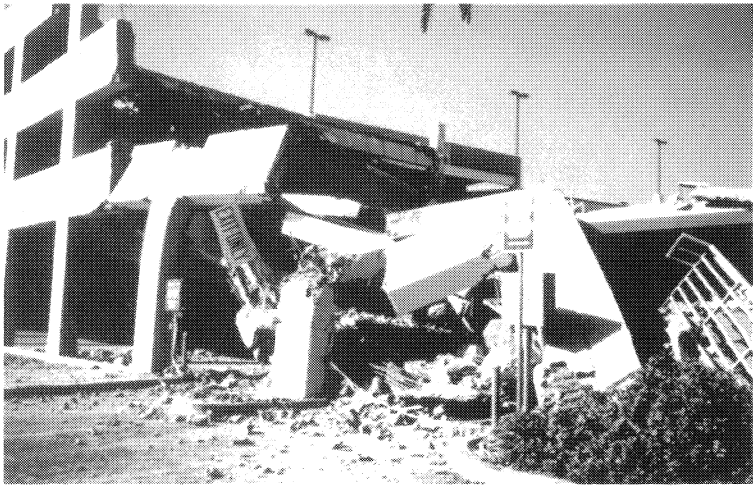
Fig. 6.7 Characteristic "Implosion" of Precast Parking Structure

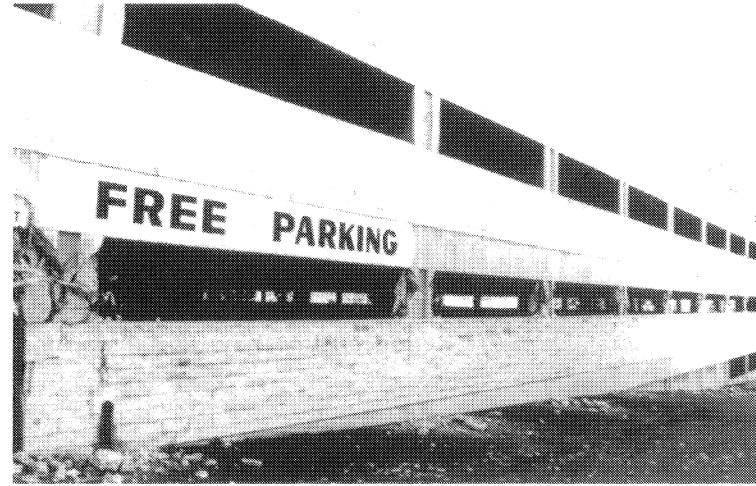
Fig. 6.8 Short Column Effect due to Partial Infill

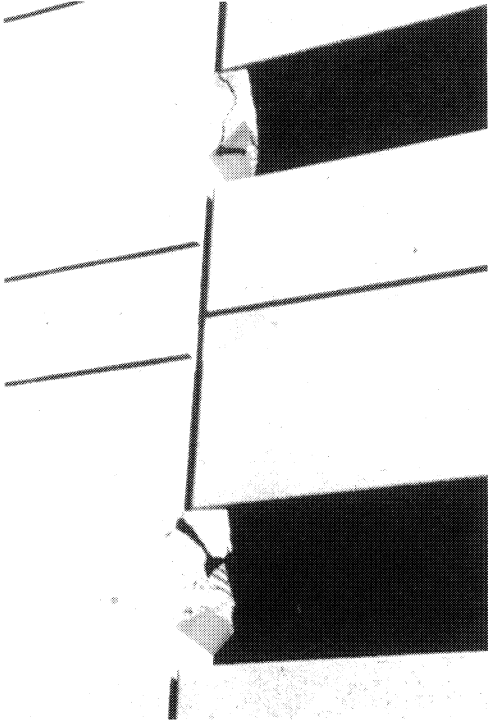
Fig. 6.9 Typical Corbel Damage in Precast Frame of Parking Garage

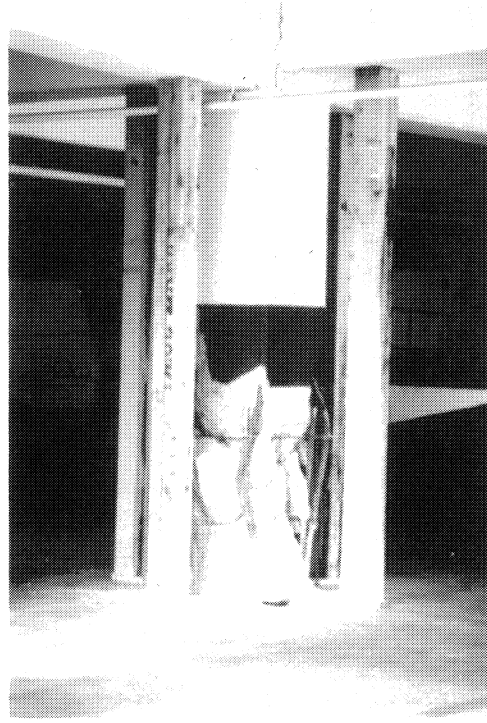
Fig. 6.10 Shear-Compression Failure of Cast-in-Place Interior Column

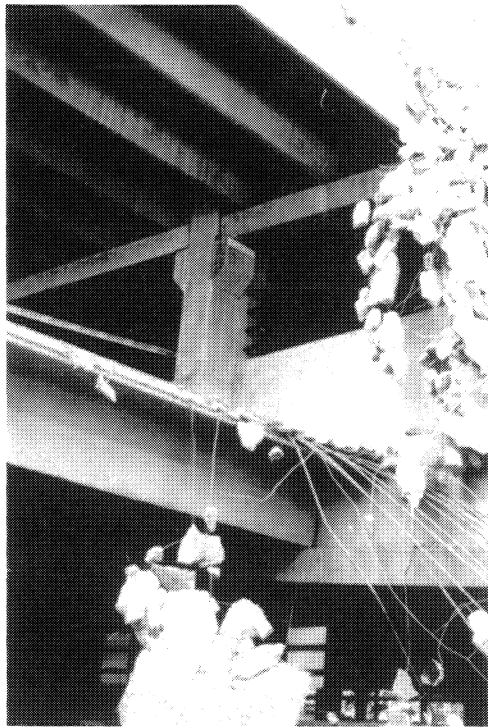
Fig. 6.11 Partial Roof Collapse with Subsequent Punching of Floors Below

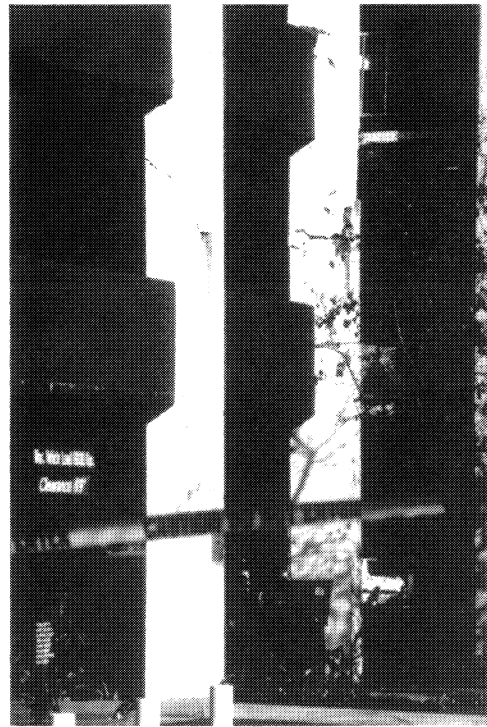
Fig. 6.12 Shear Cracking in Columns

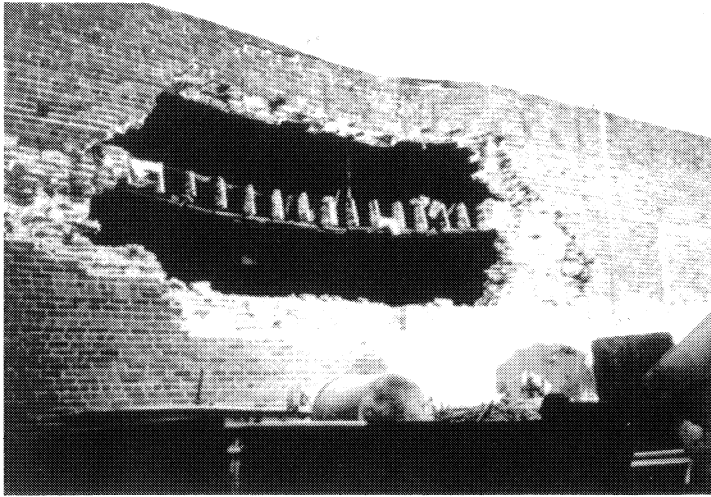
Fig. 6.13 Out of Plane Bending Failure of Retrofit URM Building

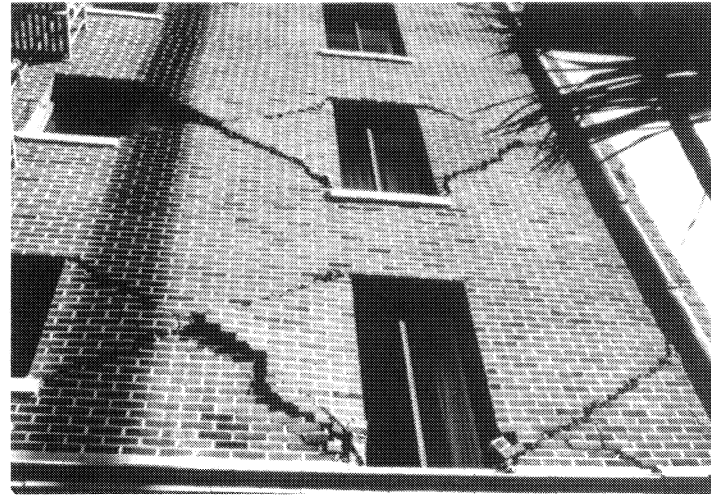
Fig. 6.14 Shear Cracking in Non-Bearing Masonry Wall

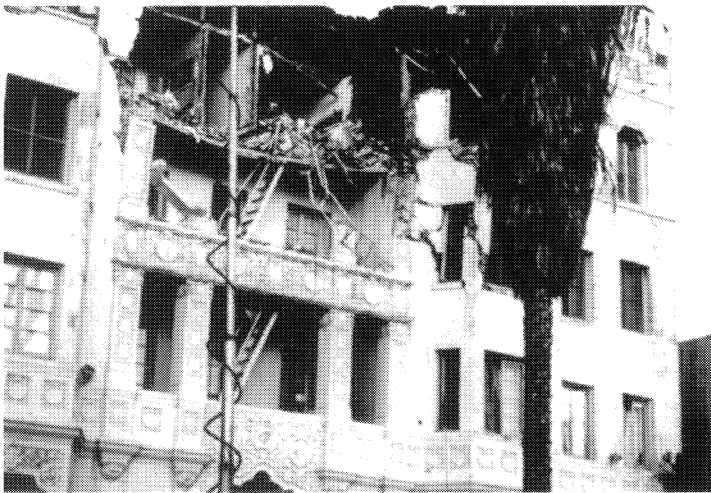
Fig. 6.15 Typical Shear and Out-of-Plane URM Failure

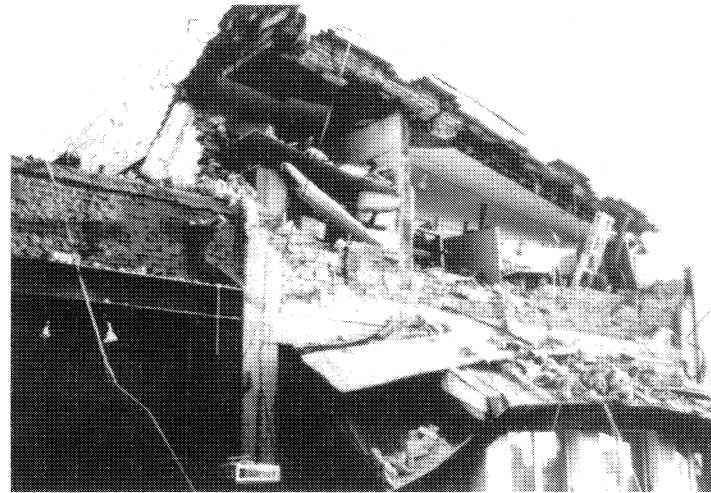
Fig. 6.16 Typical Shear and Out-of-Plane URM Failure

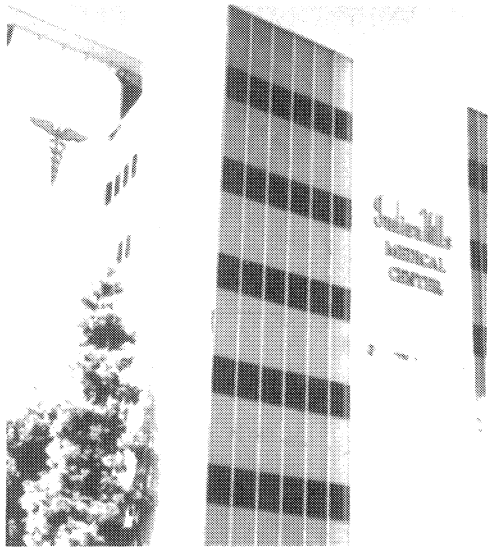
Fig. 6.17 Shear Wall Damage at Indian Hills Hospital
