REPORT NO.
UCB/EERC-94/01
JANUARY 1994

EARTHQUAKE ENGINEERING RESEARCH CENTER

**PRELIMINARY REPORT ON THE
SEISMOLOGICAL AND ENGINEERING ASPECTS
OF THE JANUARY 17, 1994
NORTHRIDGE EARTHQUAKE**

UNIVERSITY OF CALIFORNIA AT BERKELEY

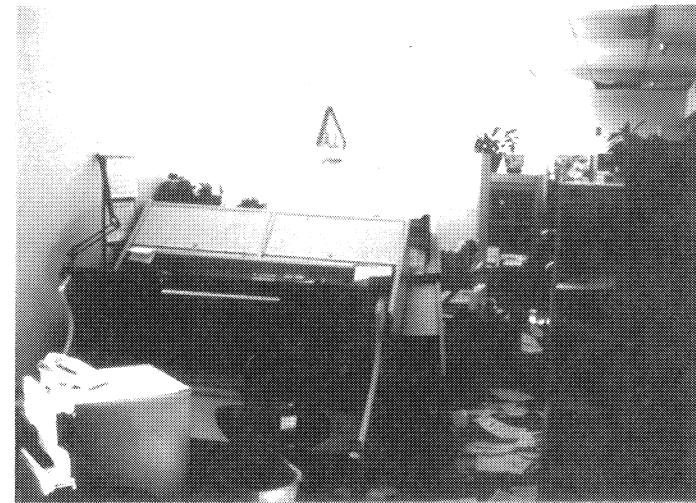
Fig. 6.18 Toppled Bookcases, Ground Floor of Veterans Hospital
