Natural hazards in Santo Domingo de Heredia, Costa Rica, Central America

Jonnathan Reyes¹, Mario Fernández^{2,3,4,5*}, Sara Grineski⁶, Timothy Collins⁶

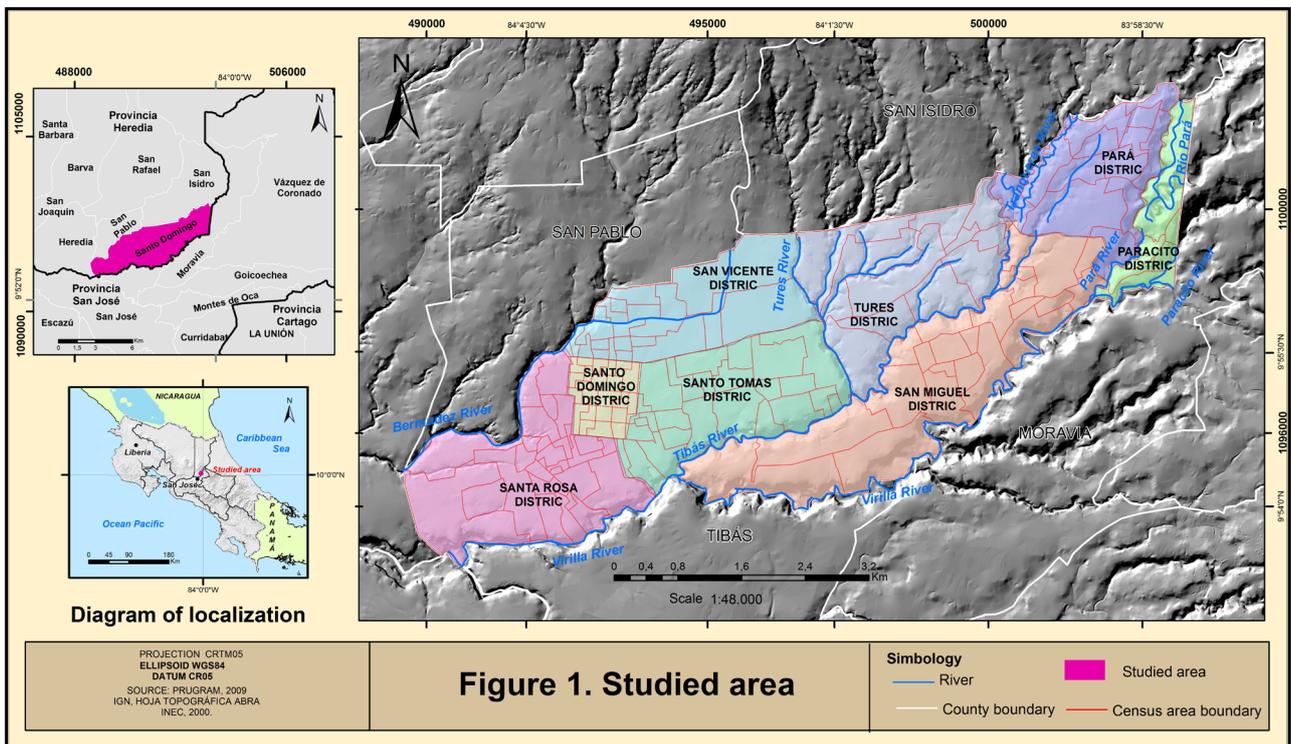
Figure 1. Studied area

Figure 1. The county of Santo Domingo and its 140 census units (small areas in which districts of Costa Rica are divided). The average size of the census units, measured in number of homes, is defined by the Instituto Nacional de Estadística y Censo (INEC) depending on the work that an interviewer can do to collect census information during a week (60 houses in the urban area and 40 in rural areas).

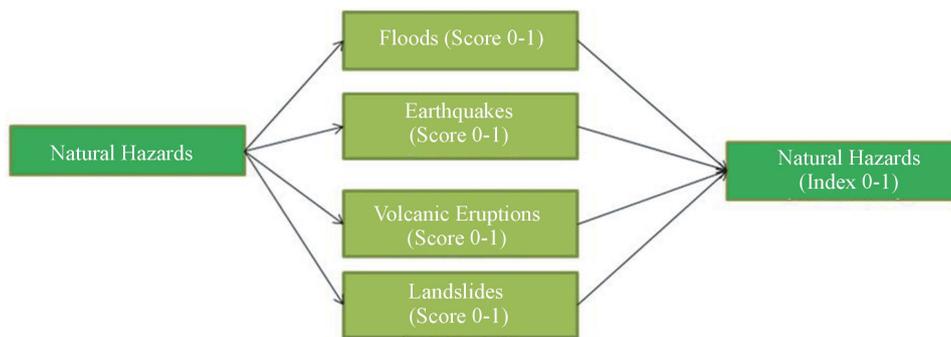
Figure 2. Diagram showing the method for creating the global hazard map for Santo Domingo.

Domingo were downscaled from national-level sources for integration in this analysis [3-6]. Field reconnaissance was used to ground truth the natural hazards maps for Santo Domingo. Then, a density score for each hazard was calculated for each census unit, based on the geographic coverage of the hazard in the unit. For example, if the unit was completely covered by the hazard, it received a score of 1; if the unit was 50% covered, it received a score of 0.50. We summed the resulting scores for each hazard and divided by the maximum value to obtain a global index of hazard density that ranged from 0 and 1. We then mapped these values at the level of the census units to create a global map of hazards for Santo

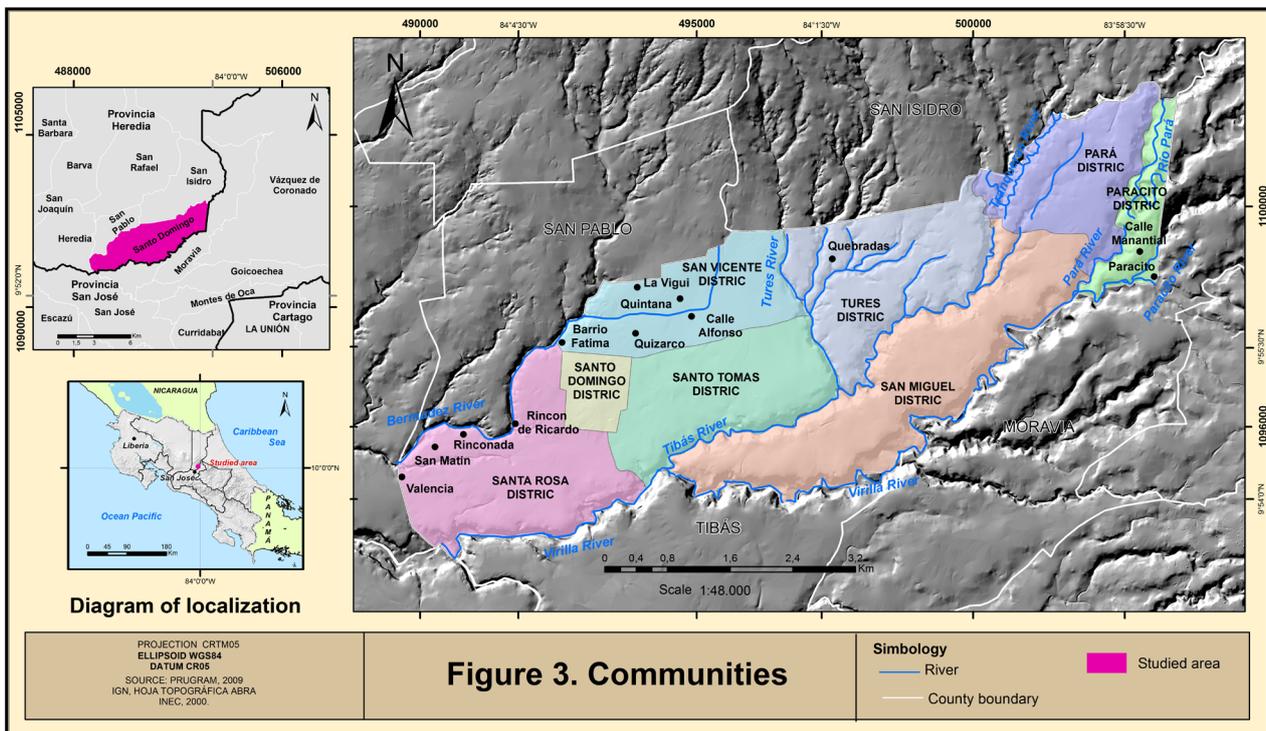
Figure 3. Communities affected by floods in Santo Domingo (black circles). The most damaged communities are located along the Bermúdez River.

The Santo Domingo *canton* is at serious risk to flooding and has experienced many serious floods over the past two decades. For example, on September 20, 1999, the Río Bermúdez overran its banks and caused a significant flood in the low-lying cities of La Rinconada, Rincón de Ricardo and Barrio Fátima (Figure 3). The water level reached 6 m above base flow and at least 74 families were seriously affected. The National Emer-

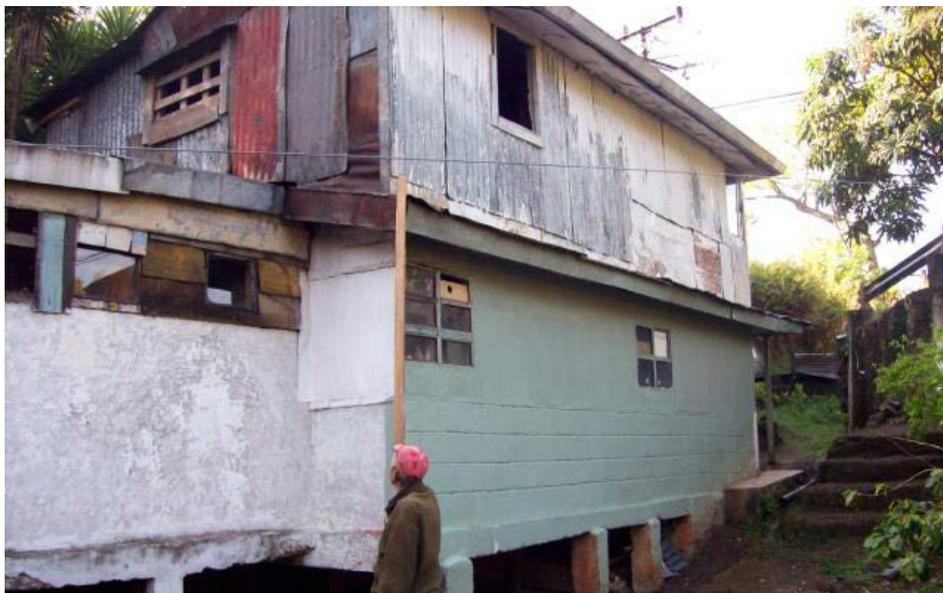
Figure 4. Flooded area in Rincón de Ricardo. Local resident Helio Fonseca shows the level reached by the water during the flood of July 2010.

Arguably the most severe flood to ever occur in the county took place on July 20, 2010 when the Bermúdez River again overflowed due to prolonged torrential downpours. The affected communities were Rincón de Ricardo, Barrio Fátima, La Rinconada and La Vigui (Figure 4). Reports from the flood detail significant damage in the area. The Local Emergency Committee reported that 22 houses were completely destroyed and that 26 homes were declared uninhabitable [10]. In Barrio Fatima, the municipality reported that 46 families were affected and 38 homes were declared uninhabitable by the Ministry of Health in Santo Domingo [11]. As a result of this disaster, authorities at the Ministry of Health advocated for the relocation of families at-risk to future floods, not permitting development in the area and

Flooding issues in the community Rincón de Ricardo along the Bermúdez River are aggravated by construction in the river flood plain and disposing of trash into the river. Trash is especially hazardous in this community because it builds up on the arched bridges from the 1940s, contributing to flooding. For example, during the great flood of 2010, water surpassed the height of a bridge, estimated at 9.32 meters.

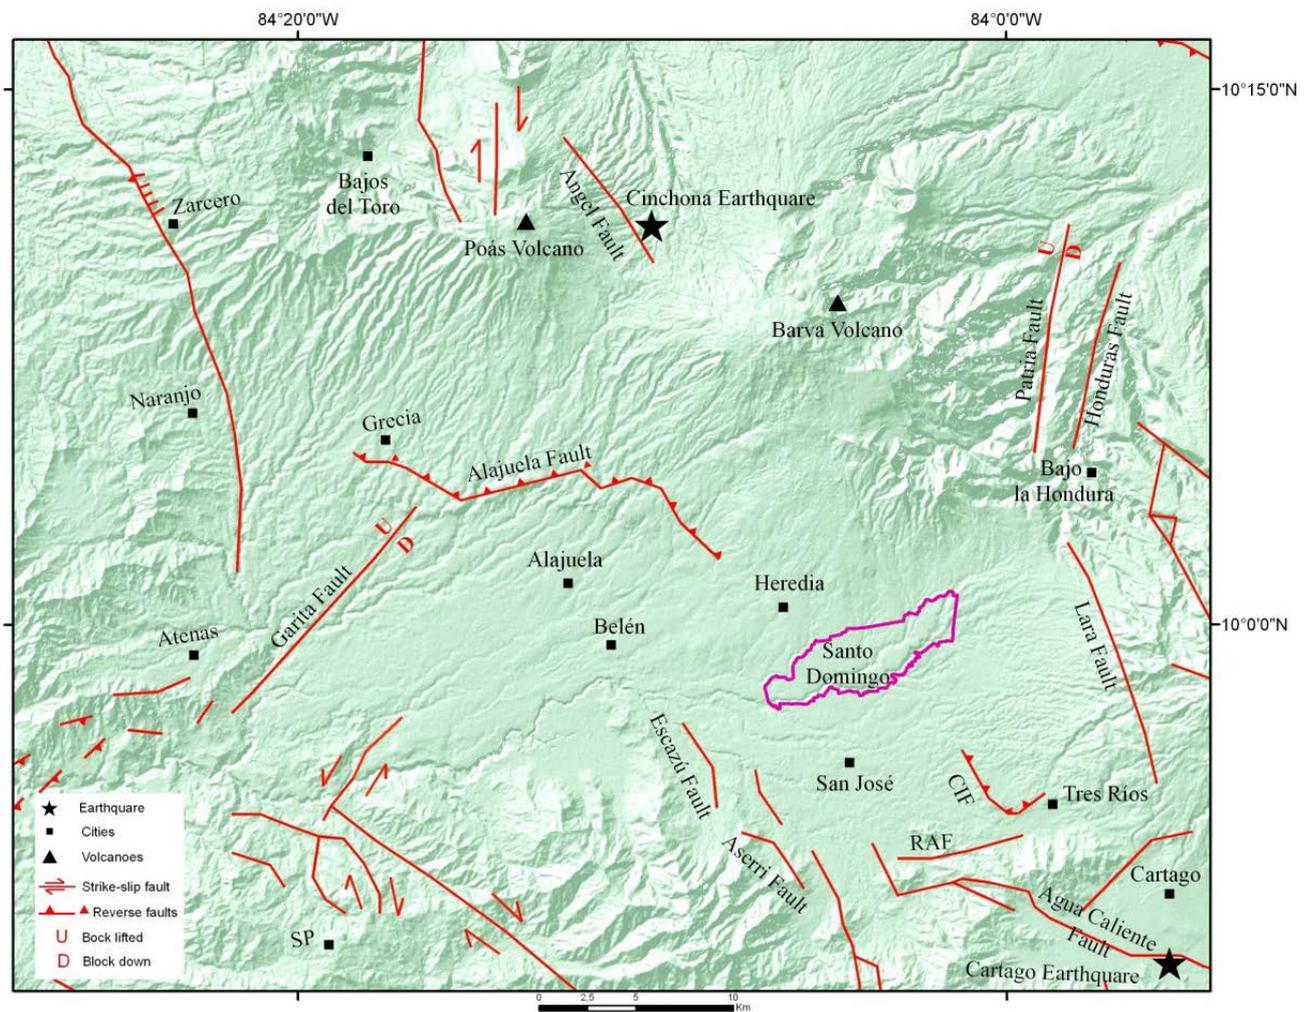
Figure 5. Faults of interest for Santo Domingo. The Alajuela, Angel, Hondura, Lara, Aguacaliente, Escazú, and Aserri faults could generate moderate magnitude earthquakes with destructive potential in the county. Epicenters of the Cartago 1910 and Cinchona 2009 earthquakes are shown as black stars.

Santo Domingo is at high risk for earthquakes, given the several fault lines surrounding the county. Santo Domingo's seismic threat is derived from the faults near Bajo la Hondura, San Jose, and the Poas volcano (**Figure 5**). The area under the Bajo la Hondura is basically a zone of short normal faults (<20 km) striking northwest. The Hondura fault is a normal one, while the Lara fault, directly east of the county, is of the strike-slip type. The Angel fault is located in the foothills of the Poas Volcano and was responsible for generating the 6.2 magnitude Cinchona earthquake in 2009. The Alajuela fault passes through the basement of the Central Valley and is a reverse fault that stretches from Grecia to near Heredia.

The most important faults southward of Santo Domingo are Aguacaliente, Escazu, and Aserrí. Each has the potential to generate earthquake damage to Santo Domingo. The Aguacaliente fault presents evidence of normal displacement [12] and is considered responsible for the Cartago earthquakes of 1841 and 1910. The Aserrí-

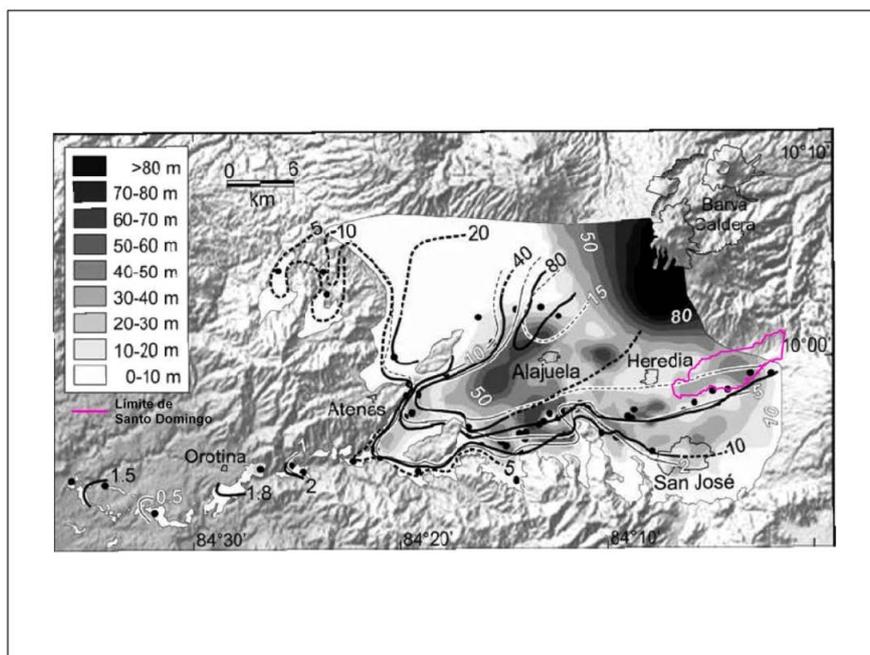
Figure 6. Map showing the area covered by the deposits of the 322,000 year ago Barva volcano eruption. Santo Domingo is the zone affected by such eruption. Grayscale indicates the thickness of volcanic deposits ranges from 10 meters and the contours of black color and black and white are isopleths, *i.e.*, lines of equal size of fragments; black lines refer to juvenile fragments and the black and white are isopleths of lithic fragments that follow a pattern similar to the of juvenile fragments. Black filled circles are the sites where fragments were sampled (adapted from [3]).

canic eruption of great magnitude near Santo Domingo county (Figure 6), which was associated with the Barva caldera, within which is the current Barva volcano. The eruption was violent and produced a pyroclastic flow that spread more than 80 km, from the vicinity of the current Barva volcano to beyond the city of Orotina. Associated deposits from the volcano are up to 80 meters deep in some places, mainly near the Barva volcano. As shown in Figure 6, the current territory of Santo Domingo was severely affected by the event, having been covered by a layer of material up to 30 meters. If people would have been living there at the time, the consequences would have been tragic. The deposit was left by a single flow, not by a series of flows that would have been more manageable, which would have made it particularly devastating. This type of volcanic activity represents a serious hazard for the population of central Costa Rica [3], which includes residents of Santo Domingo.

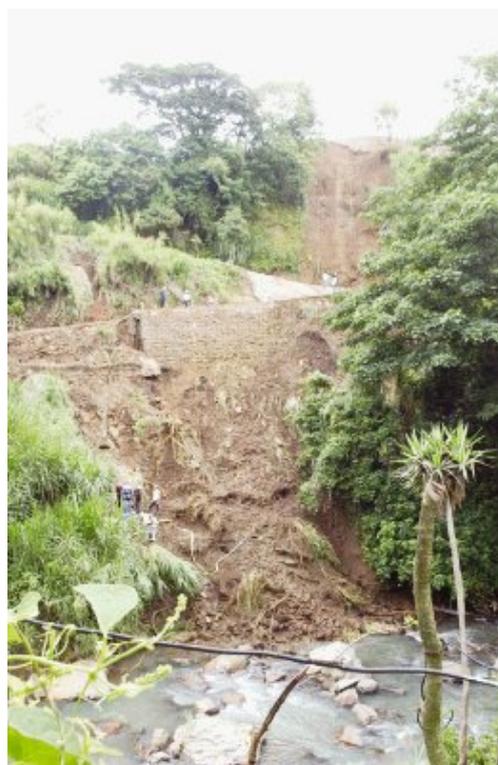
Figure 7. The deadly landslide of July 2008. Courtesy of Periódico Aldía.

River canyons in the study area are prone to landslides. Landslides, like all mass earth movements, involve the down slope movement of materials, under the influence of gravity; they can be triggered by rains, earthquakes and human activity [2]. In the county of Santo Domingo, the river canyons associated with the Virilla, Tibás, Bermúdez, Pará and Paracito rivers are especially at risk. **Figure 7** shows a deadly landslide from July 2008. After an intense rain, this landslide carried two cars to the bottom of the river, killing one person.

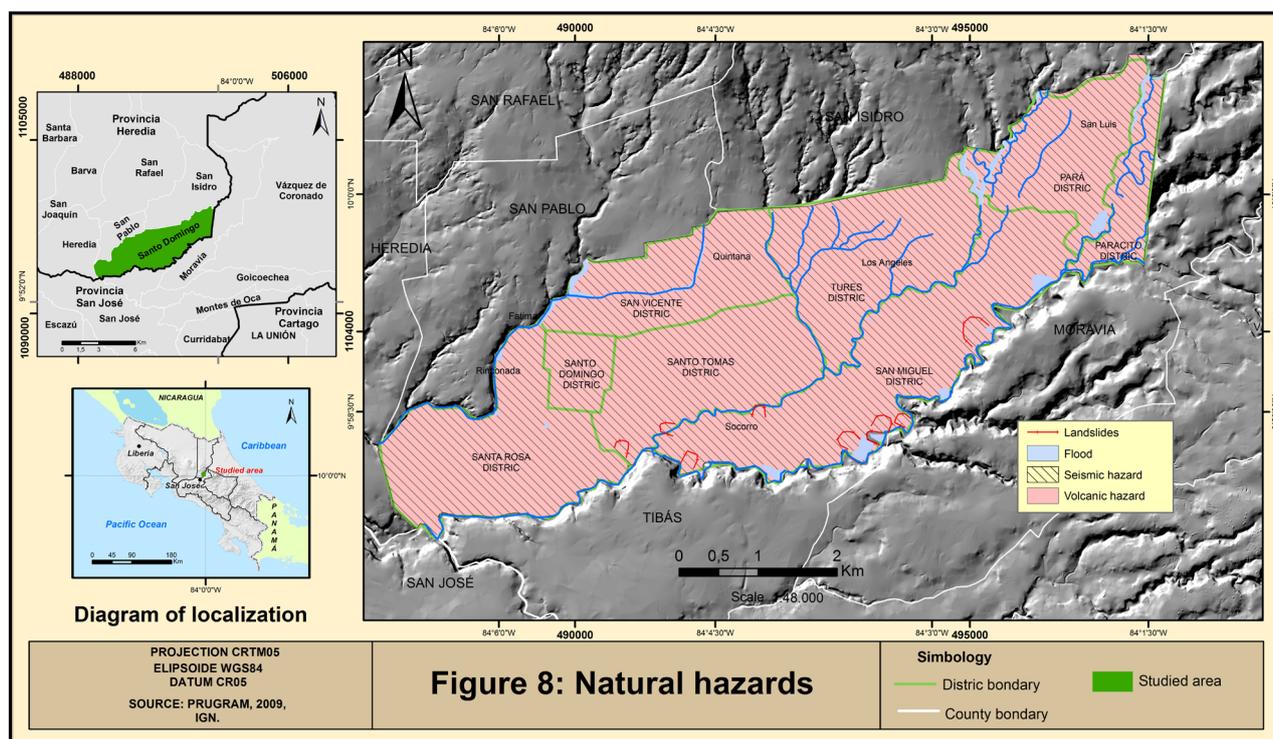
Figure 8. Natural hazards of Santo Domingo.

Based on the data for seismicity, volcanic activity, landslides, and flooding we made a map with the spatial distribution of hazards in the county of Santo Domingo (**Figure 8**). Each biophysical variable was intersected

with the layer of census unit in order to obtain the density of natural hazards by area. Figure 8 shows the distribution of hazards in the zone. It can be observed in the map that both the seismic and volcanic hazards span over the entire area of Santo Domingo.

The longitudinal area along the canyon of the Virilla River presents the highest hazard in the county, while places between the rivers have minor threat because they are in the topographic plateau and therefore are relatively flat. As can be observed from the map, the southern part of the county has the main concentration of hazards. The northern part has a lower density of hazards.

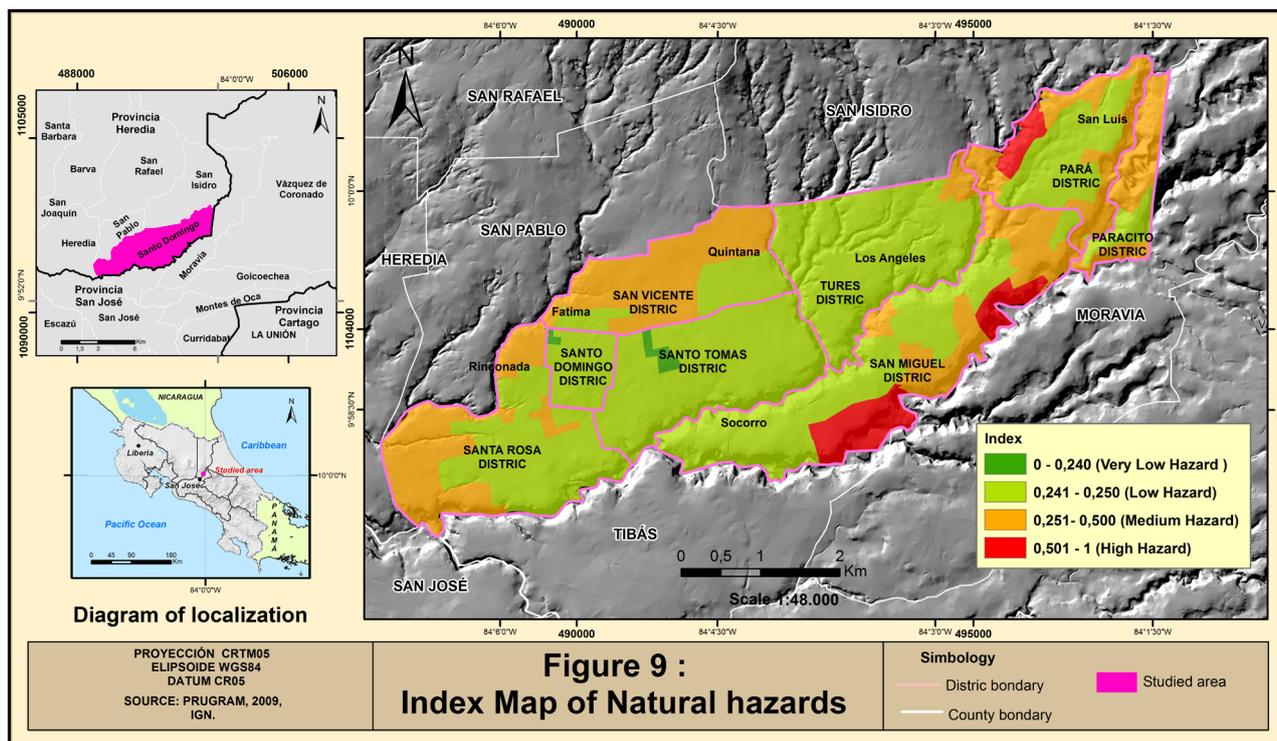
Figure 9. Spatial distribution of natural hazards in Santo Domingo according to the computed density hazard index.

Figure 9 shows the natural hazard density index for Santo Domingo de Heredia, which integrates each of the four hazards (with equal weighting) into one hazard score at the level of the census unit. While flooding and landslide risk are spatially variable, all census units within Santo Domingo are at risk from seismic and volcanic hazards. The map shows that the central part of the county has generally low hazard density. This is because it is flat and only affected by earthquakes and relatively low-impact volcanic activity. Along the northern and southern bounds of the county, the hazard density index increases to medium due to the possibility of flooding in these areas. The areas with the highest density of hazards are also on the edges of the county, mainly in the South. These areas are close to river canyons with the risk of flooding and landslides. There are some “high risk” places

like, La Quintana in the north and Santa Rosa in the west, that are relatively flat and not in river canyons; in these areas it is damaged or inefficient sewage systems that put them at risk of significant flooding during high rainfall events.
