REPORT NO.
UCB/EERC-94/01
JANUARY 1994

EARTHQUAKE ENGINEERING RESEARCH CENTER

**PRELIMINARY REPORT ON THE
SEISMOLOGICAL AND ENGINEERING ASPECTS
OF THE JANUARY 17, 1994
NORTHRIDGE EARTHQUAKE**

UNIVERSITY OF CALIFORNIA AT BERKELEY

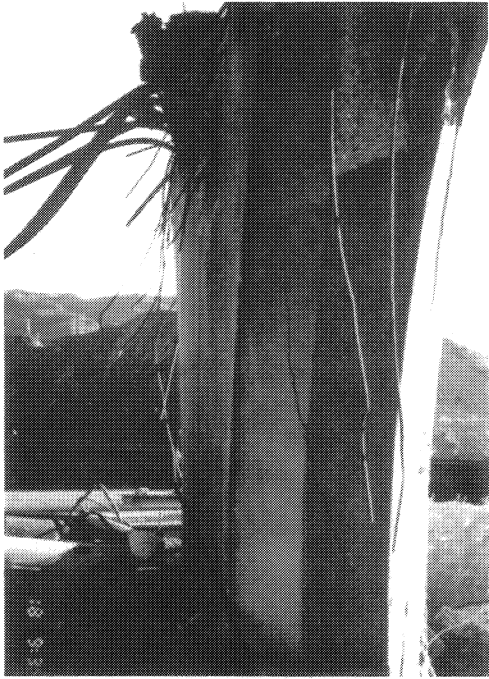
Fig. 5.6: Bent 3 of Interstate 5/Route 14, South Overhead

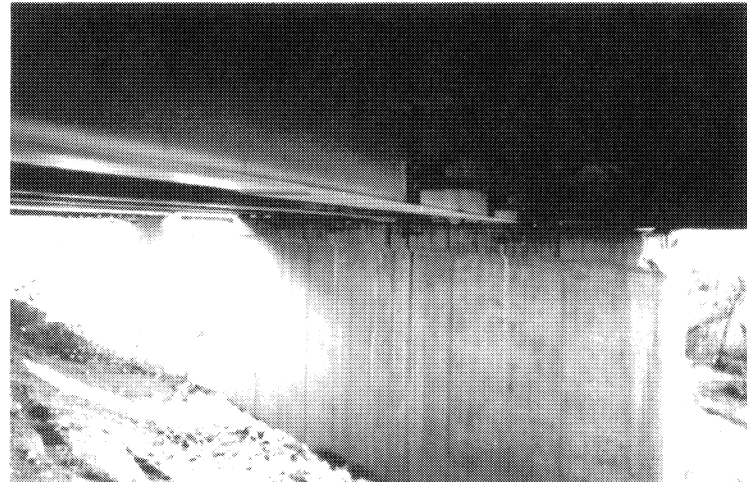
Interstate 5 crosses the Santa Clara River on two skewed seven-span bridges, each consisting of a concrete deck over six steel plate girders bearing on concrete pier walls and abutments. Pounding damage was observed between the concrete barrier rails and abutments, and at intermediate hinges. Concrete spalled about the plate girder anchorage at the top corner of the pier wall closest to the abutments (Fig. 5.21). Anchor bolts (1.5 in. diameter) attaching the eastern girders of each bridge to concrete pedestals were sheared off. Cable restrainers had broken at these locations, some by pullout of the cable from the swaged end and others by fracture of the cable (Fig. 5.22). Lock nuts on several cable restrainer connections were observed to be loose by several turns. Relative displacements of at least 3.25 in. longitudinally and 4 in. transversely were

Fig. 5.21: Pier Wall at Southbound Span of Santa Clara River Bridge Looking South

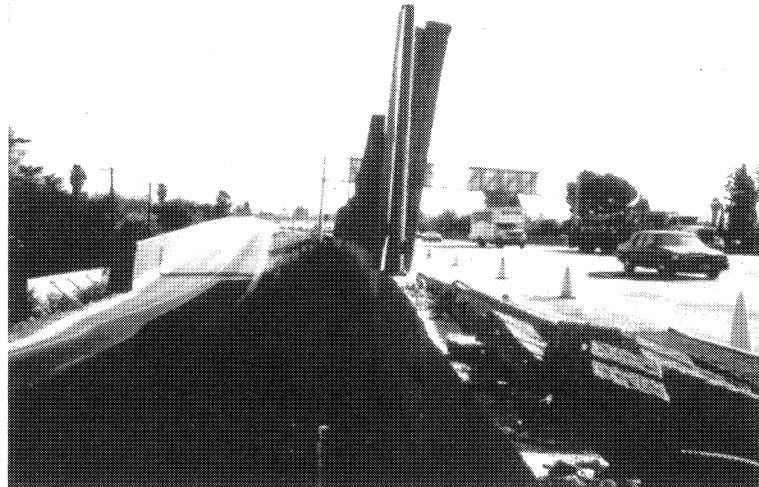
Soundwalls constructed on concrete barriers along the northern edges of Route 101, just east of Interstate 405, were observed in various conditions. Some walls, shown in Fig. 5.25, have remained vertical, others have rotated, and another has collapsed to the south. The collapsed wall has #5 longitudinal reinforcement placed in every fourth cell (approximately 32 in. on center) of a precast masonry panel. Lap splices of approximately 28 in. in length begin at the base of the wall. Concrete had been placed in the cells containing longitudinal reinforcement with one exception. At every location the wall reinforcement had failed near the connection to the concrete barrier rail. Approximately one-half of the bars failed by fracture. Signs of necking were not observed, and the fractures occurred as far as 10 in. below the wall/barrier interface. The remaining bars had lap splice failures. The precast masonry was disrupted at the end of the wall where a lap splice failure was observed.

Fig. 5.25: Sound Walls at Route 101 near Interstate 405

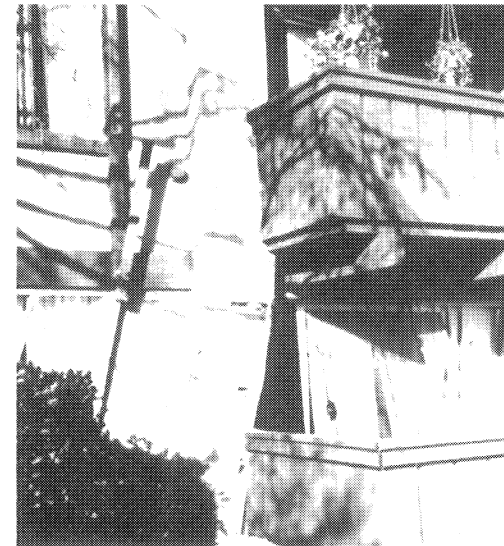
Fig. 6.20 Soft Story Collapse of Wood Apartment Building
